Final Hydrological and Ecological Assessment Report

Identification of areas for baseline and continuous monitoring of water quantity in the Negril Environmental Protection Area, and Scenarios for reduced sedimentation and improved regularity of water flow based on degrees of land use change and restoration needs in the areas of intervention

Consultancy for the Hydrological Assessment of a Wetland Ecosystem

Prepared by Environmental Solutions Limited for the National Environment and Planning Agency (NEPA)

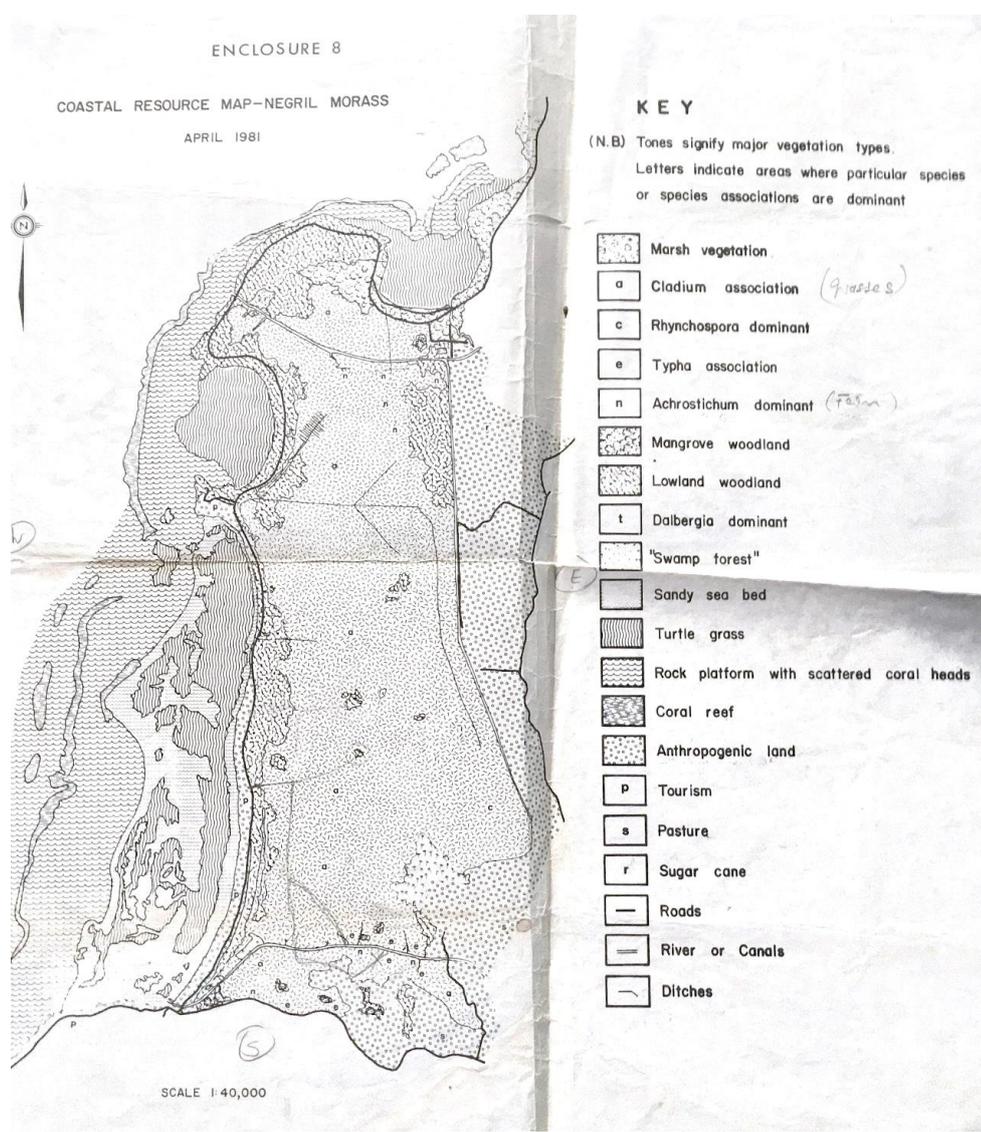
Figure 1 Coastal ecosystems of the Negril Great Morass (NRCD & Traverse Group, 1981)

The vegetation of the Negril Great Morass has been previously described by NRCA (1981) (Figure 1), Coke (1982) (Figure 2) and Caribbean Ecosystems Ltd (2001). A detailed assessment of the Negril Royal Palm Forest was carried out in 1986 (Anderson *et al.* 1986). Several other assessments of the coastal woodlands and associated habitats have been conducted as part of environmental impact assessments. The Forestry Department effected detailed assessments of the mangroves in 2019-2021. An assessment of the impacts of fire in the Morass was carried out by Lewis (2010) and of invasive plants in the Royal Palm Reserve by Duever (2009). A list of species has been compiled from these studies (Appendix A). This list provides detailed geographical coverage for the wetlands, coastal woodlands, and swamp forest, but there have been no botanical assessments of the adjacent limestone forests. However, the assessments are all more than 20 years old, and are therefore much in need of updating.

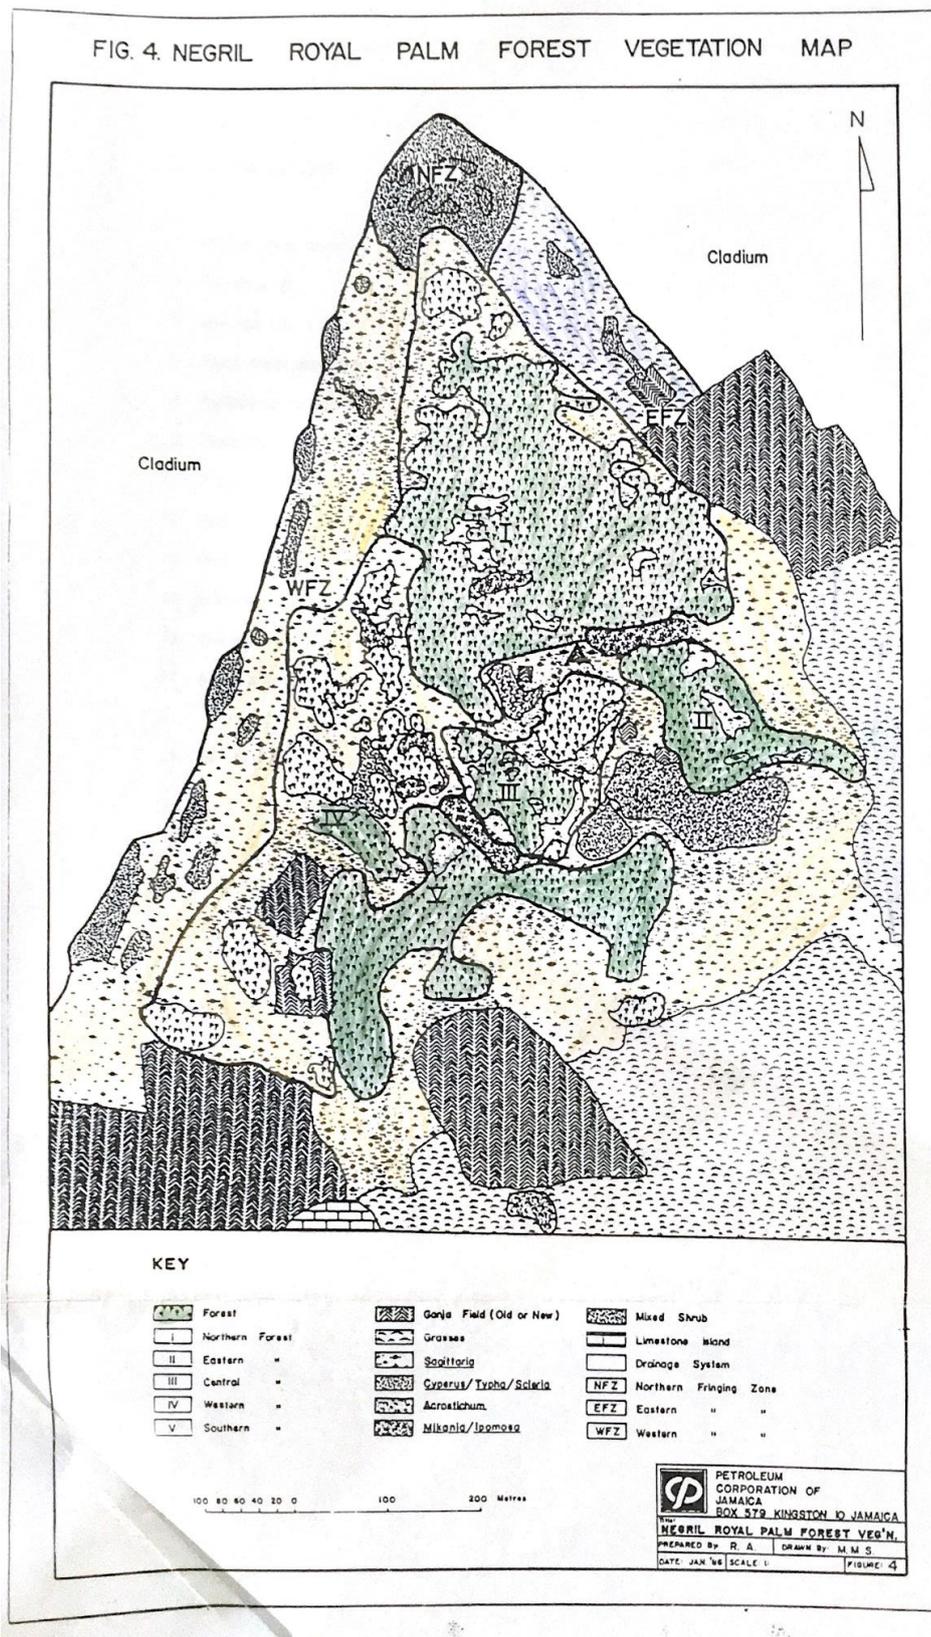
Figure 3 Vegetation of the Royal Palm Reserve before construction of the boardwalk, ponds and structures (Anderson et al. 1986)

The swamp forest of the Royal Palm Reserve (Figure 3) was described in detail by Anderson *et al.* (1986). They divided the swamp forest into three main zones: forest stands, clearings and fringing zones.

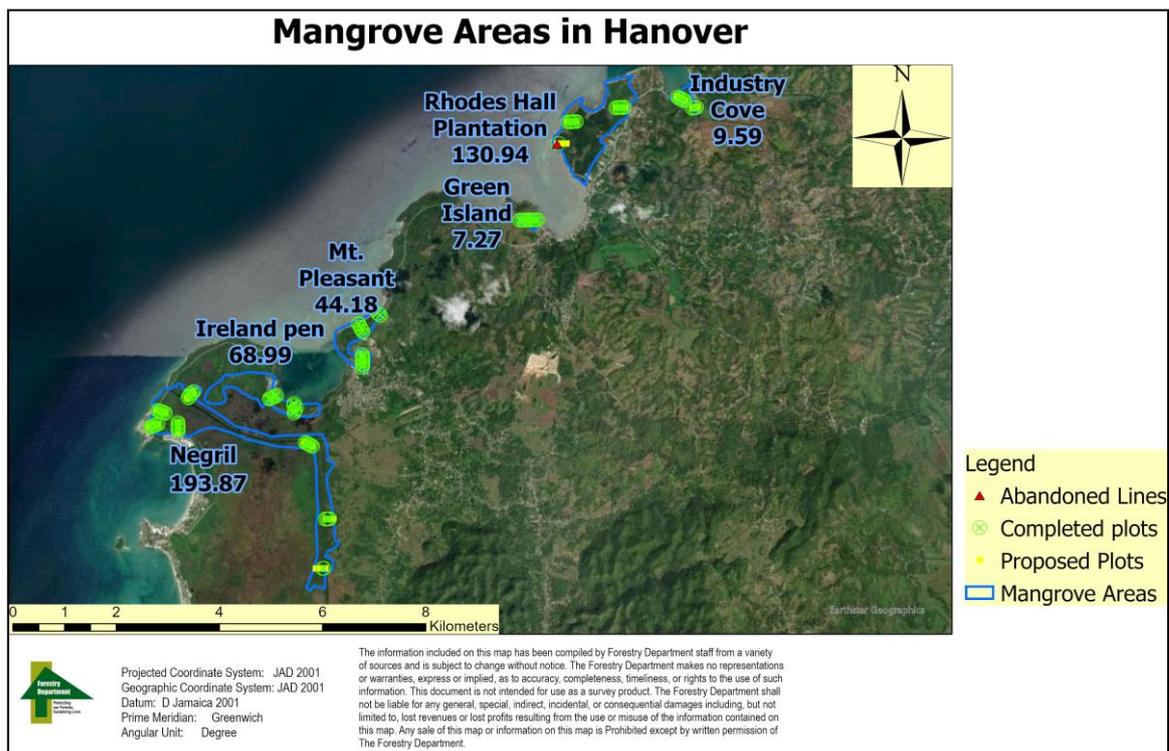
Figure 5 Locations of mangrove survey plots (Source: Forestry Department, 2001)

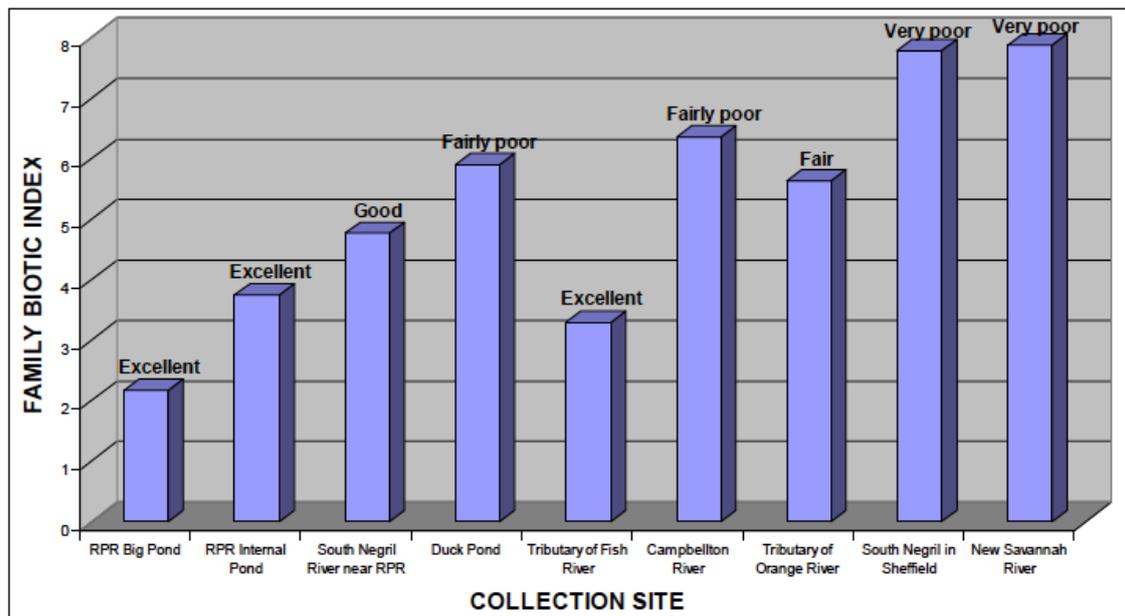
Figure 8 Graph showing water quality at sites in the Morass and other parts of the Negril EPA based on family biotic index (NEPA 2007)

There is no available information on the current ecological condition of these sites except for the North Negril River (NEPA 2019) (Figure 8). This analysis suggested that conditions at NNR1 were good, but NNR2 was worse.

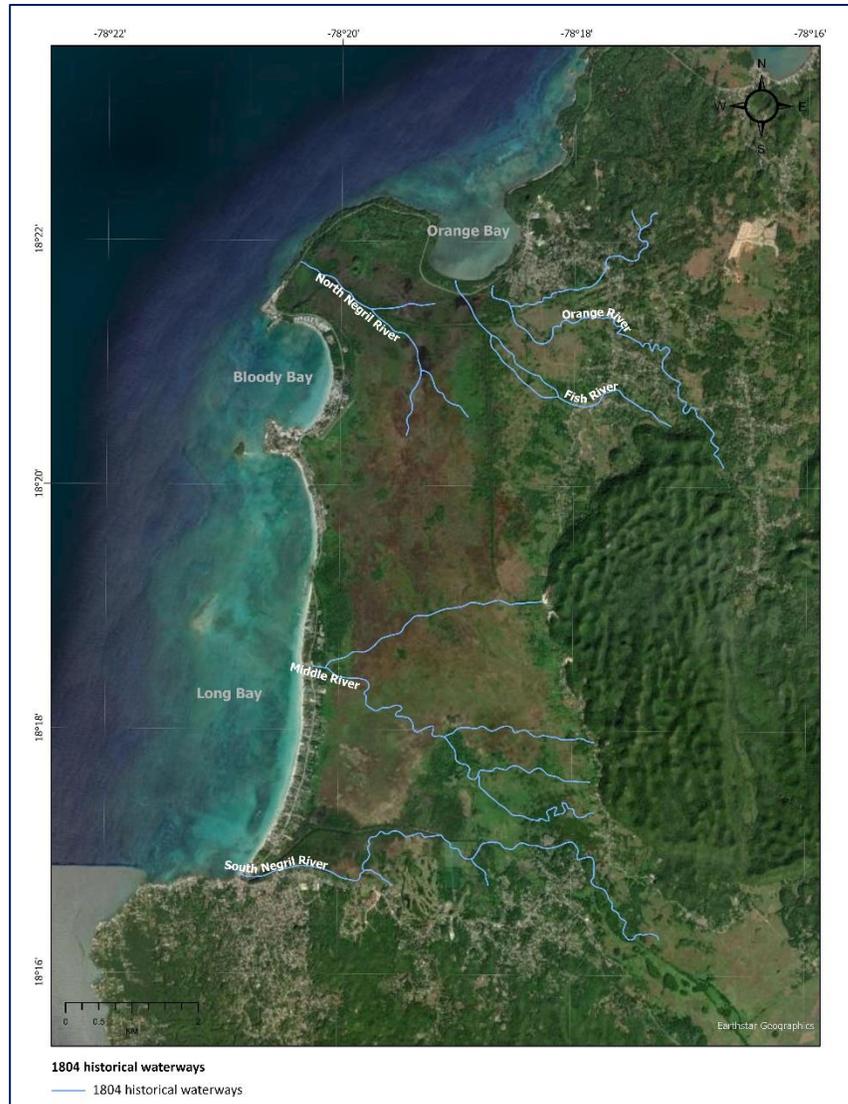
Drawing 2 River routes in Great Morass in 1804

The earliest records (Robertson, 1804) confirm the natural surface water flow regime prior to any drainage modifications consisted of four main river systems (see Drawing No. 2).

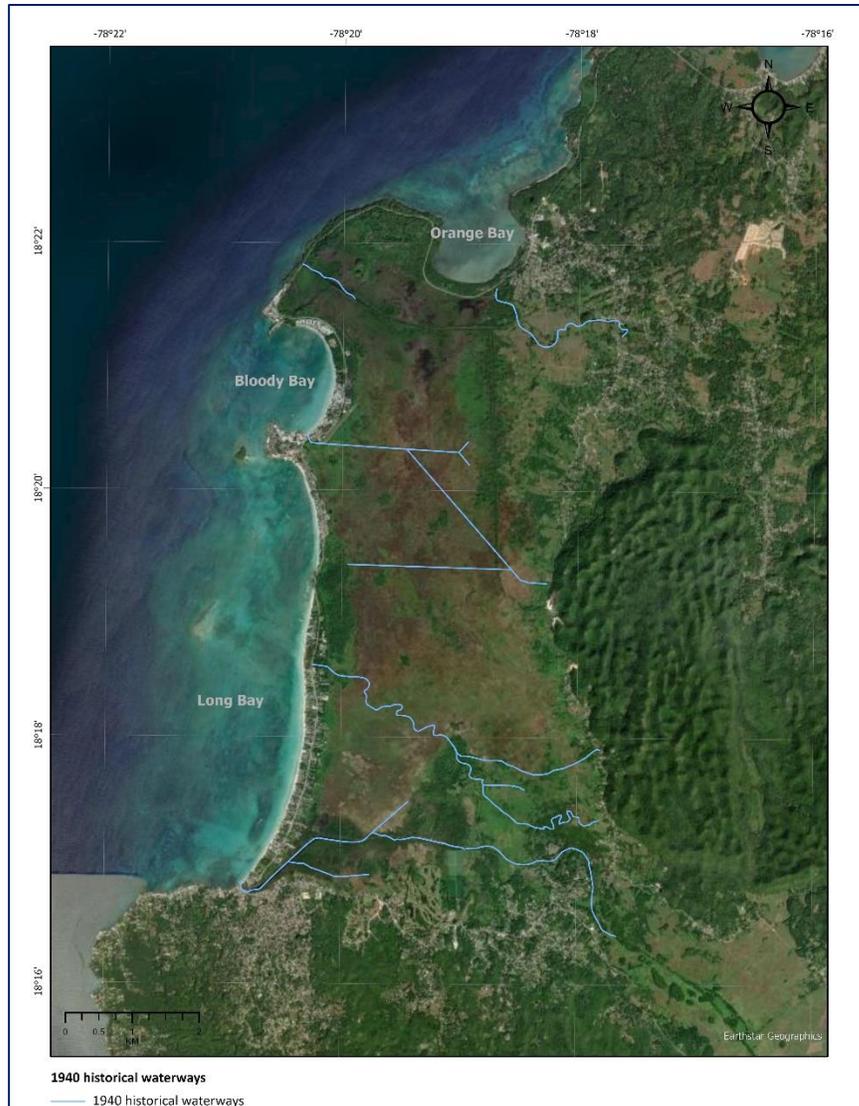
Drawing 3 River and drainage routes in the Great Morass in 1940

As late as 1940 (Robinson & Hendry, 2012) the 1940-1941 aerial photographic survey (see Drawing No.3) showed:

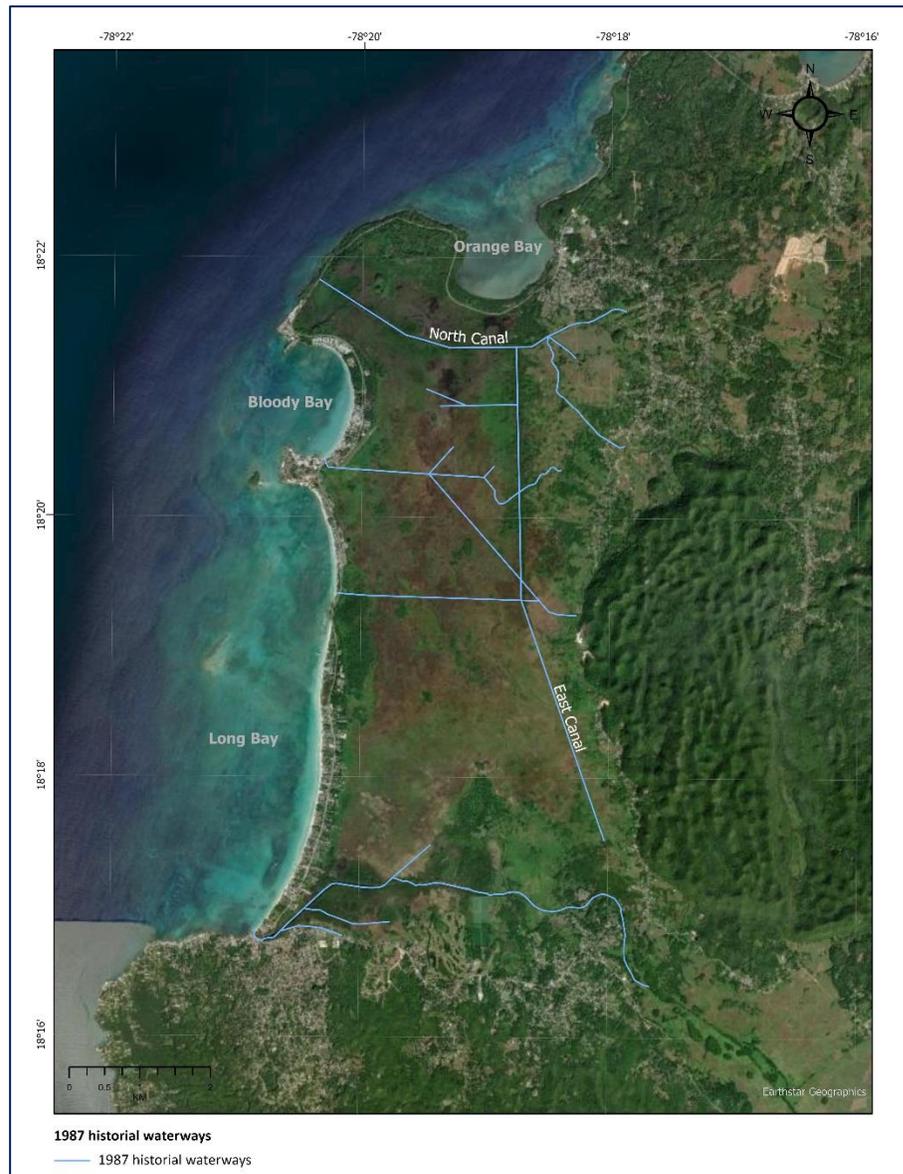
Drawing 4 Drainage and river routes in the Grand Morass in 1987

In the 1950's a major drainage programme was initiated, which drastically changed the drainage routes of the Morass, to those largely observed today (see Drawing No. 4).

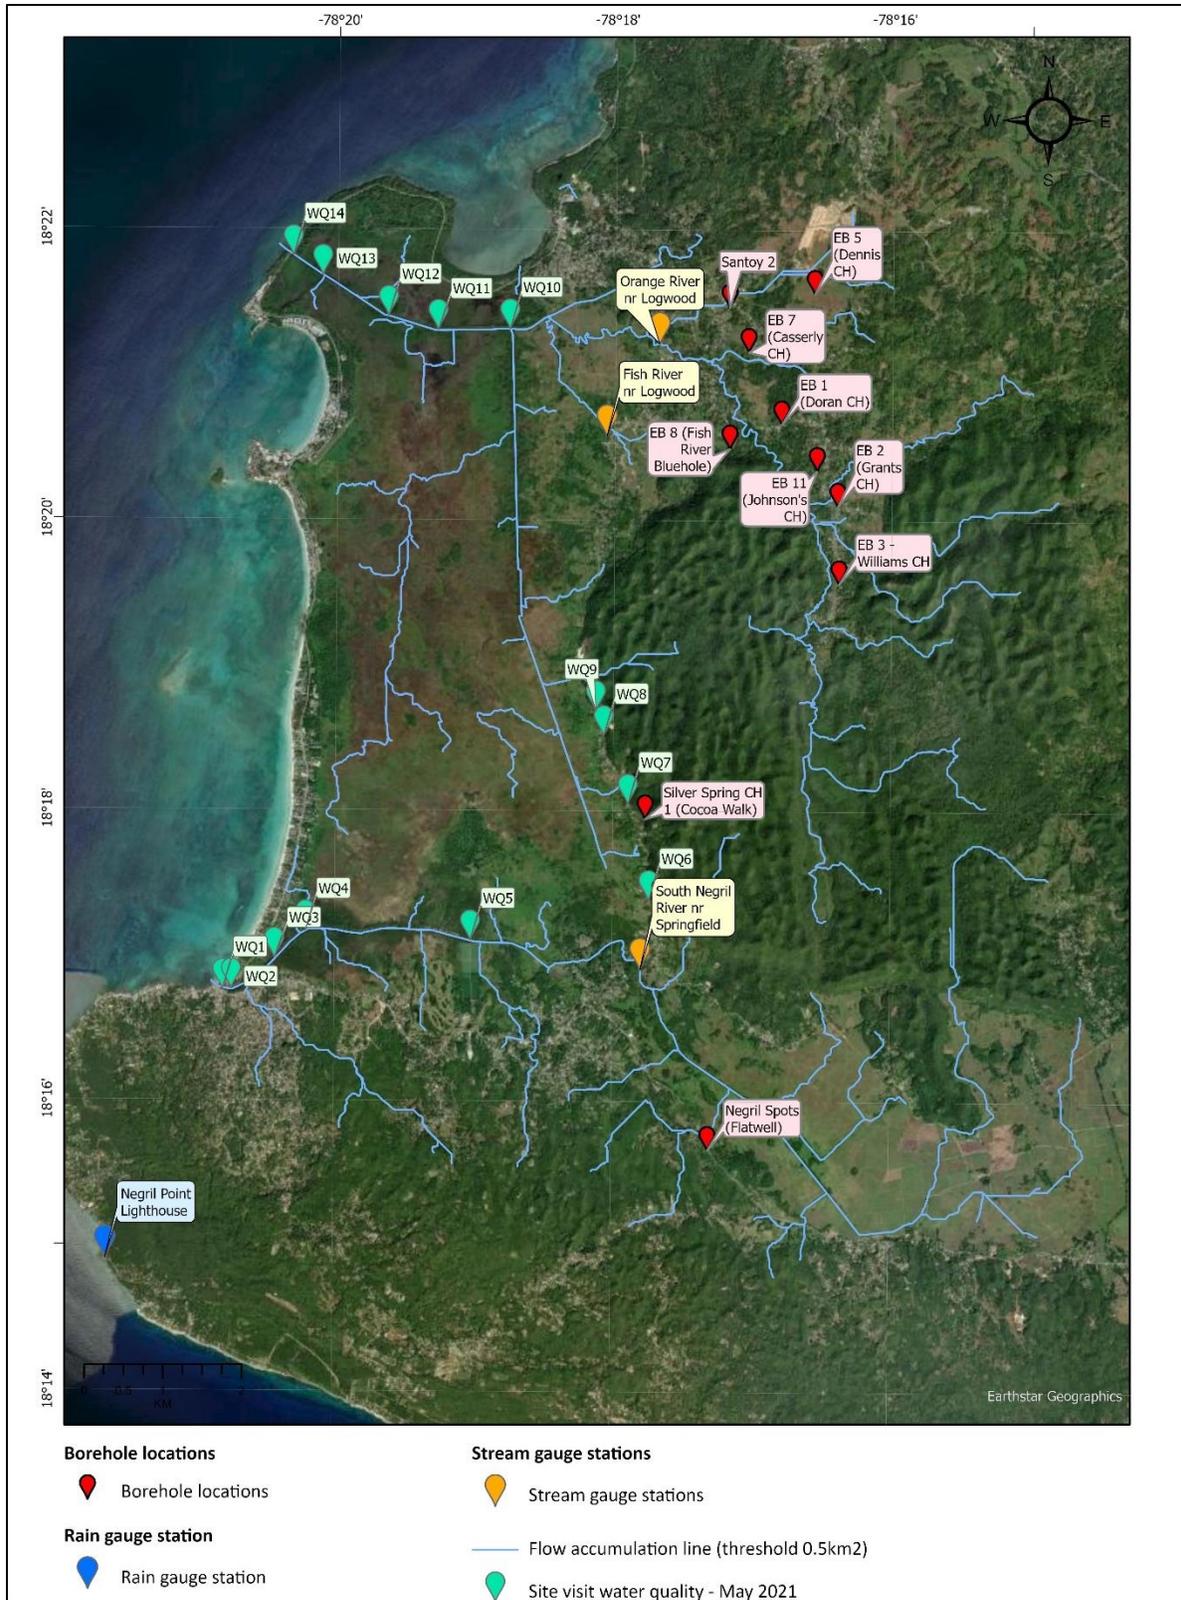
Drawing 5 Existing Meteorological and hydrological monitoring network

The hydrological monitoring network for the Great Morass is somewhat limited (see Drawing No. 5) due to the largely inaccessible nature of the wetland.

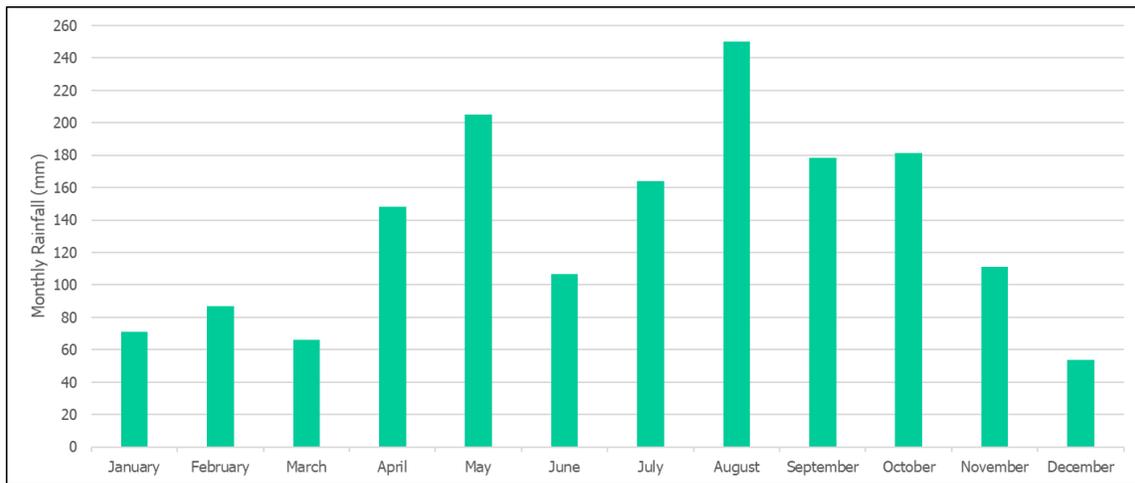
Figure 13 Average monthly rainfall at Negril Lighthouse, 1989-2020

More than 30 years of rainfall data exists. A summary of average monthly rainfall data is shown below (Figure 13). This clearly shows the bi-modal nature of rainfall in Jamaica, with lower rainfall in December to March and June to July.

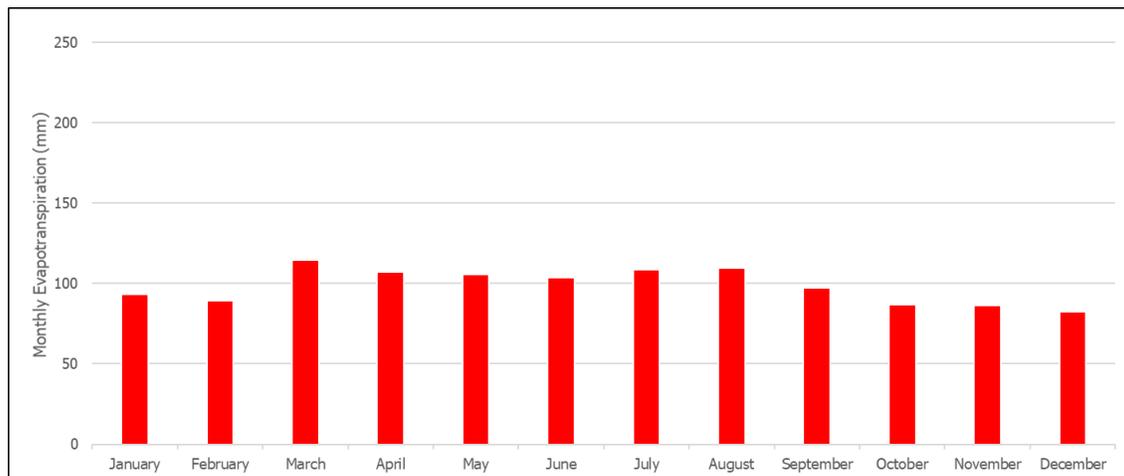
Figure 14 Average monthly evaporation data at Negril Lighthouse, 1989-2020

Average monthly evaporation data shows a more uniform seasonal distribution, see Figure 14 below.

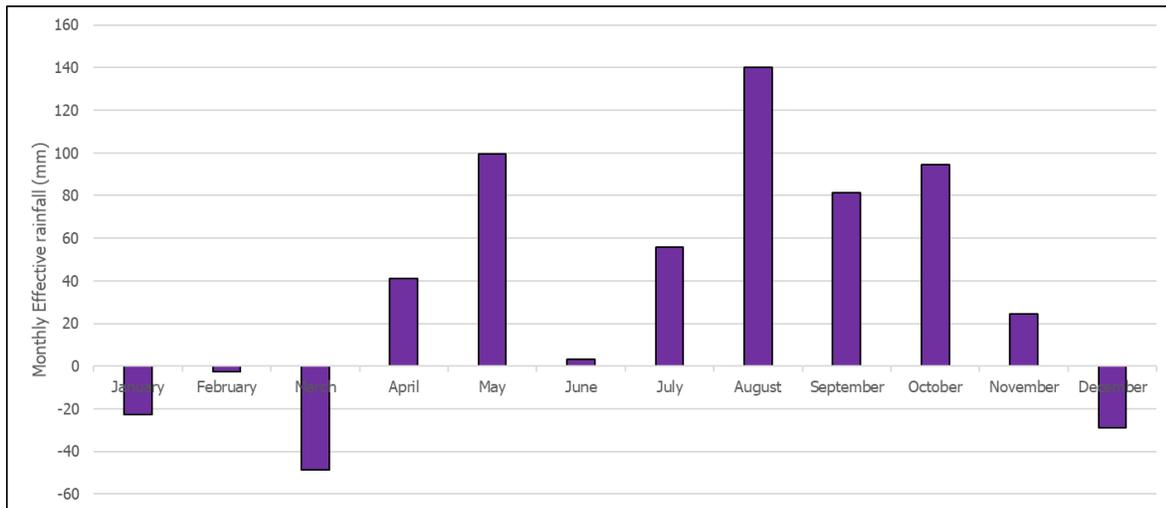
Figure 15 Average monthly effective rainfall at Negril Lighthouse, 1989-2020

Whilst a crude analysis, the below graph (Figure 15) shows the wetland will naturally get increasingly dry seasonally from December to March, before being re-wetted by effective rainfall April to November.

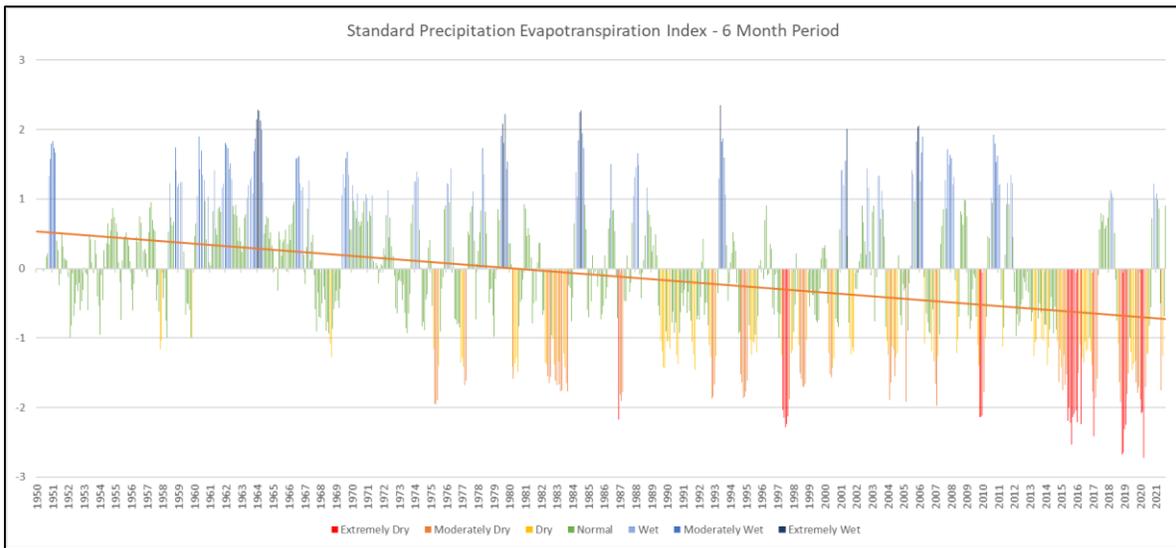
Figure 17 6-month Standard Precipitation Evapotranspiration Index (SPEI-6) for West Jamaica

The graph below (Figure 17) shows the trend in effective rainfall (normalised) with time. As before +2 means very wet periods and -2 means very dry periods.

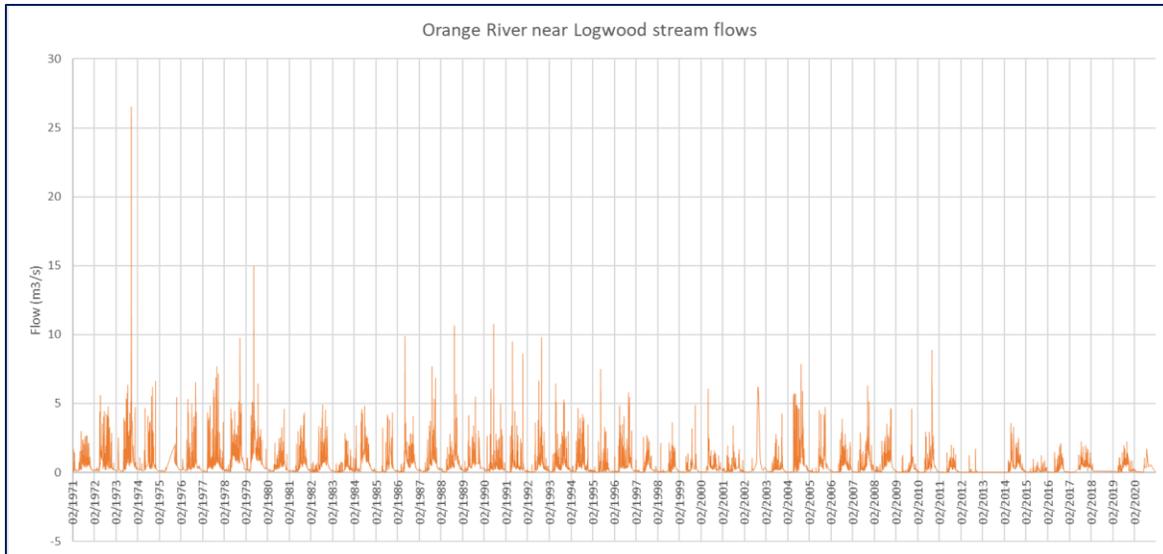
Figure 18 Orange River Flow Hydrograph

The graph below (Figure 18) shows the WRA reported flows in the much larger of the two catchments belonging to the Orange River, dating back to 1971, over 5 decades.

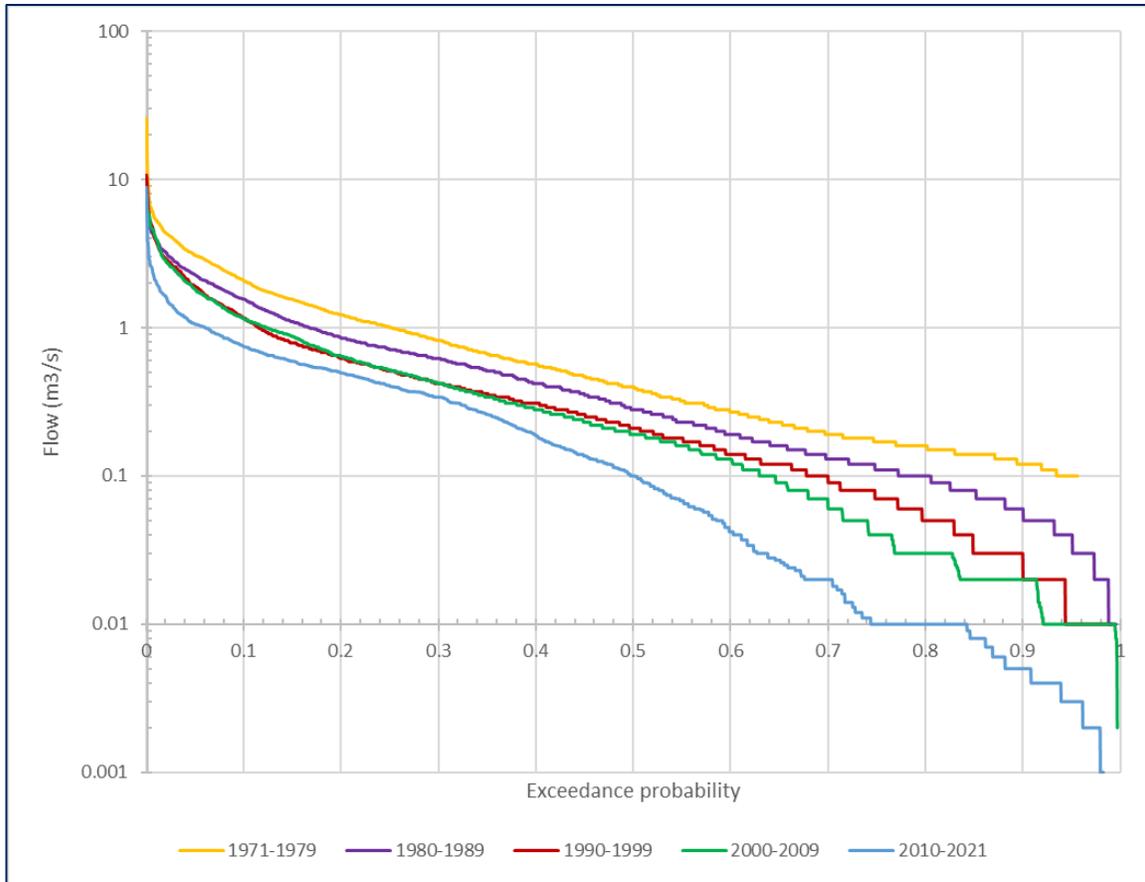
Figure 19 Orange River Flow Duration Curve

The graph below (Figure 19) shows a flow duration curve for the Orange River, separated decade by decade. The x-axis shows the percentage of the time the flow on the y-axis has been exceeded – so for example (taking the blue line) 0.5 (or 50%) of the time, the flow is greater than 0.1m³/s (*i.e.*, 100 l/s) – note the y-axis is on a logarithmic scale.

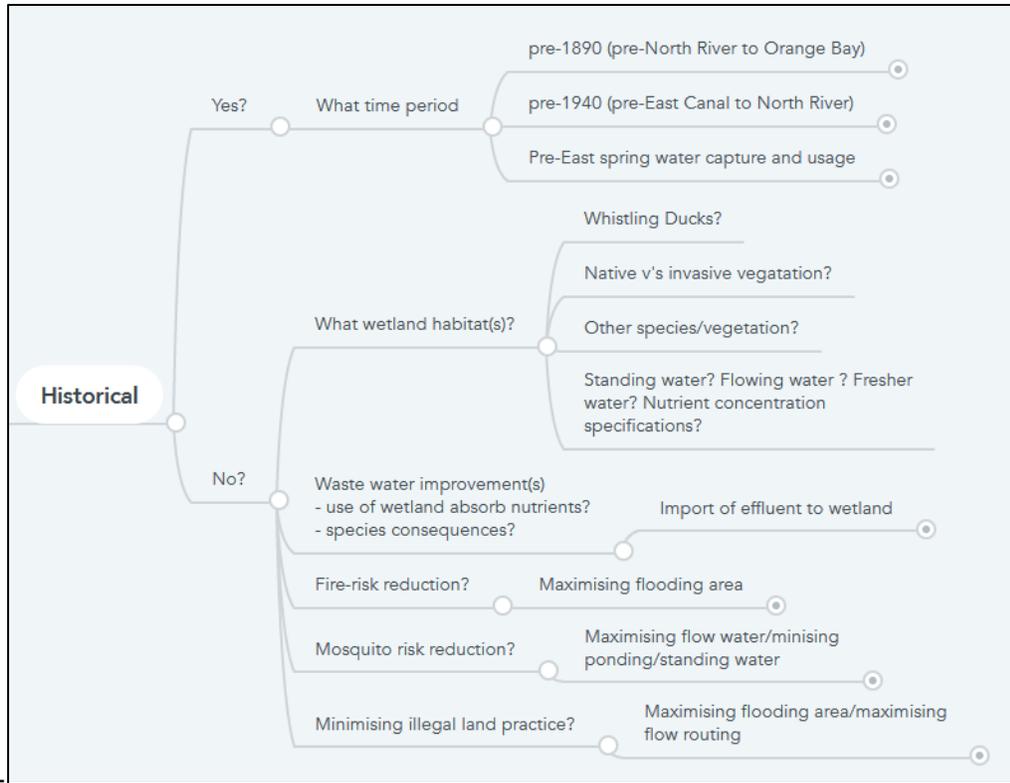
Figure 20 Hydrological Restoration Options Decision Tree Analysis

- the extent to which a historical restoration should be achieved, and if so which date – *e.g.*, removal of the East Canal, removal of the Orange River, re-capturing the eastern groundwater springs.
- the extent to which specific species should guide hydrological improvements *e.g.*, the West Indian Whistling Duck – and what hydrological conditions its preferred habitat requires.
- the extent to which wild bush fire risks should be reduced.
- whilst being mindful of mosquito breeding risks; and
- the need to avoid impacts on legitimate landowners' activities.

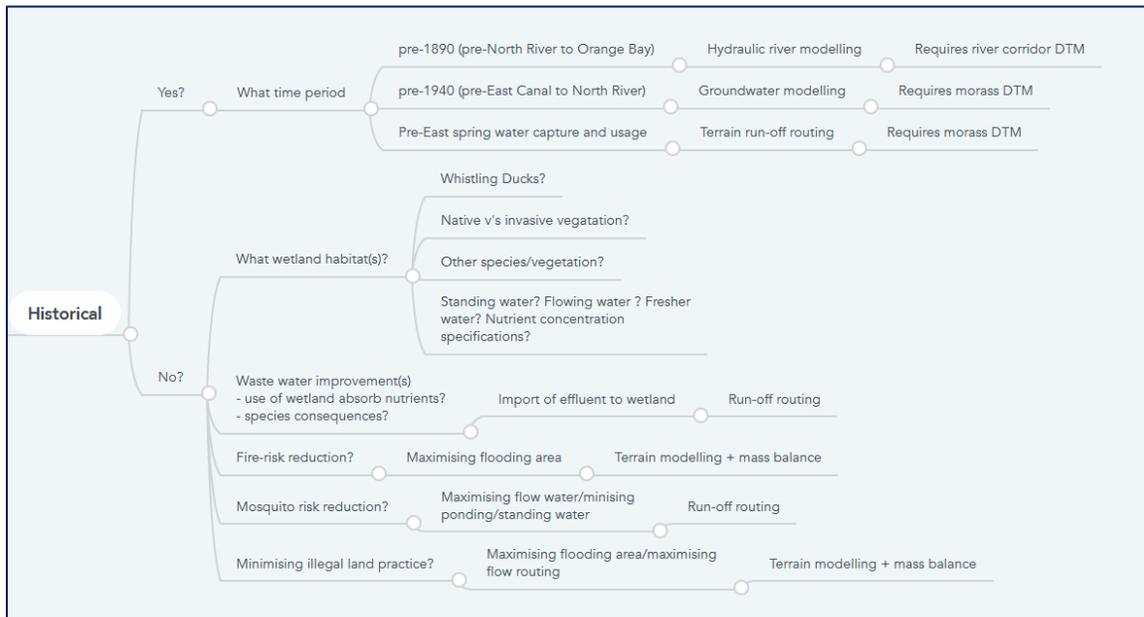
Figure 21 Relationship between hydrological restoration objectives and hydrological model selection

The critical importance of first establishing the hydrological restoration goals is further explained in Figure 21 below. Each possible objective requires modelling of different components of the hydrological cycle, which then requires the use of particular modelling approaches: hydraulic modelling for the rivers; groundwater modelling for the hydrogeological regime; and/or terrain run-off modelling for the rainfall run-off within the Morass.

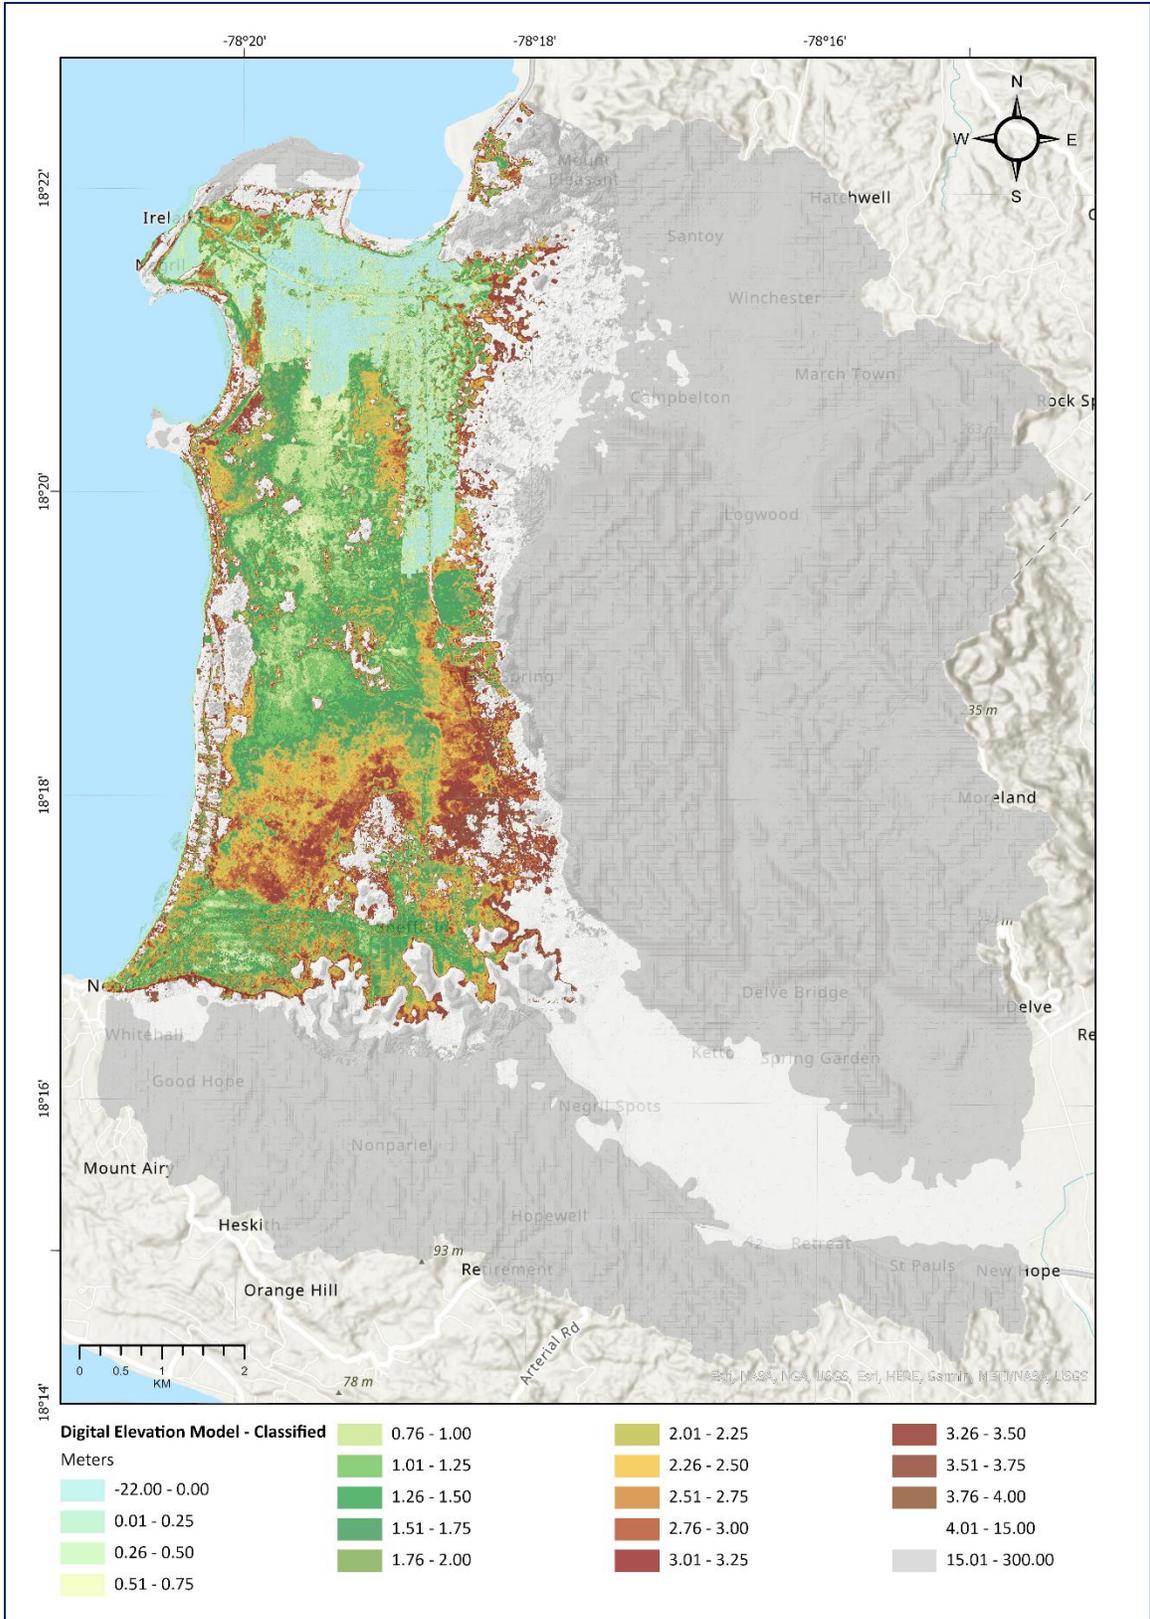
Drawing 6 Digital Elevation Model of the Negril Great Morass

Whilst impressive in the detail and granularity that can be seen in the DEM, an audit of the DEM, comparing the elevations to the high-resolution aerial photography used in the surveying process, identified that dense vegetation canopy was captured in the DEM and consequently any elevations in the DEM above 4mAmSL were in fact vegetation.

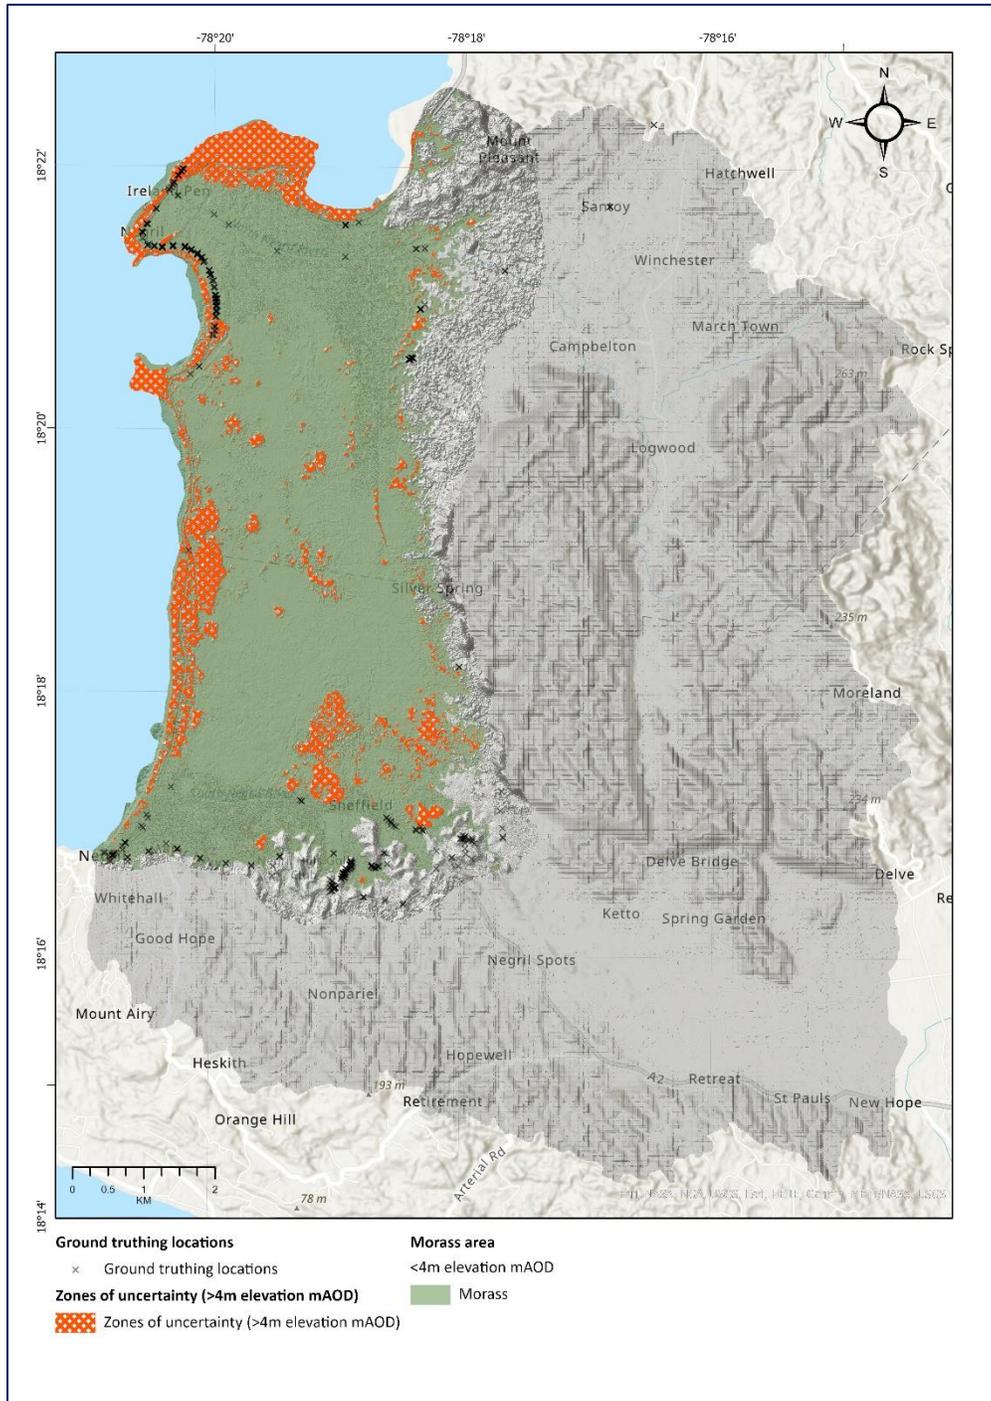
Drawing 7 Morass DEM split into zones of certainty and uncertainty

Using this elevation as a criterion to distinguish wetland ground surface from tree vegetation canopy allowed the following 'zonation' of the DEM into areas that were considered 'trusted' or 'reliable' and those that were considered 'zones of uncertainty' within which rainfall-run-off modelling could not be considered to be accurate.

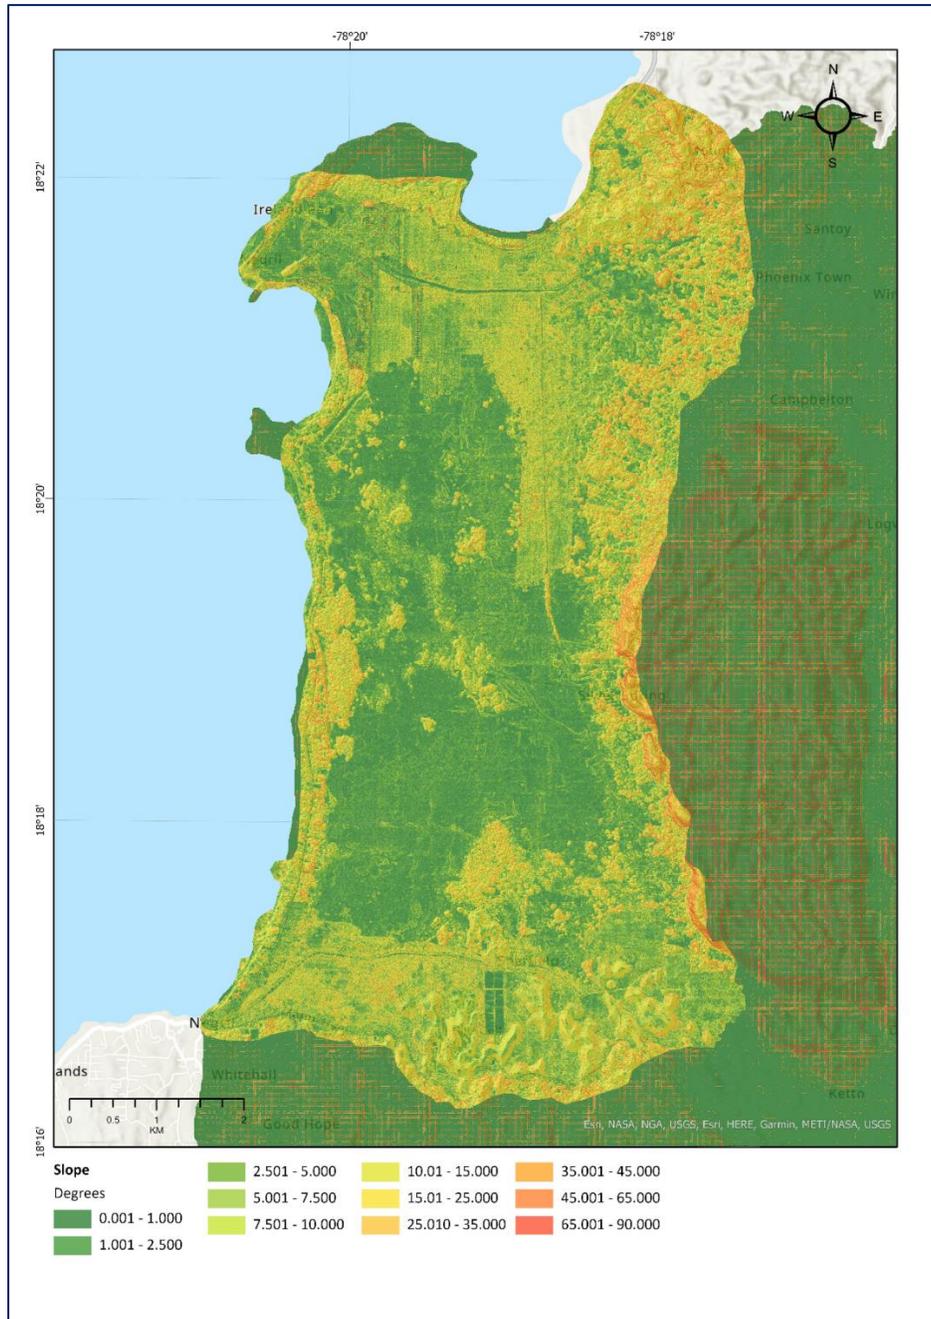
Drawing 8 DEM Slope Map

A second screening tool was used to assess the reliability of the DEM. This used the slope or gradient of the DEM in any location to distinguish between the very flat Morass and the very steep change in DEM which could only be explained by the DEM including vertical trees. The slope map is shown below. Green colours are flat slopes, red near vertical slopes, and yellows slope angles in between.

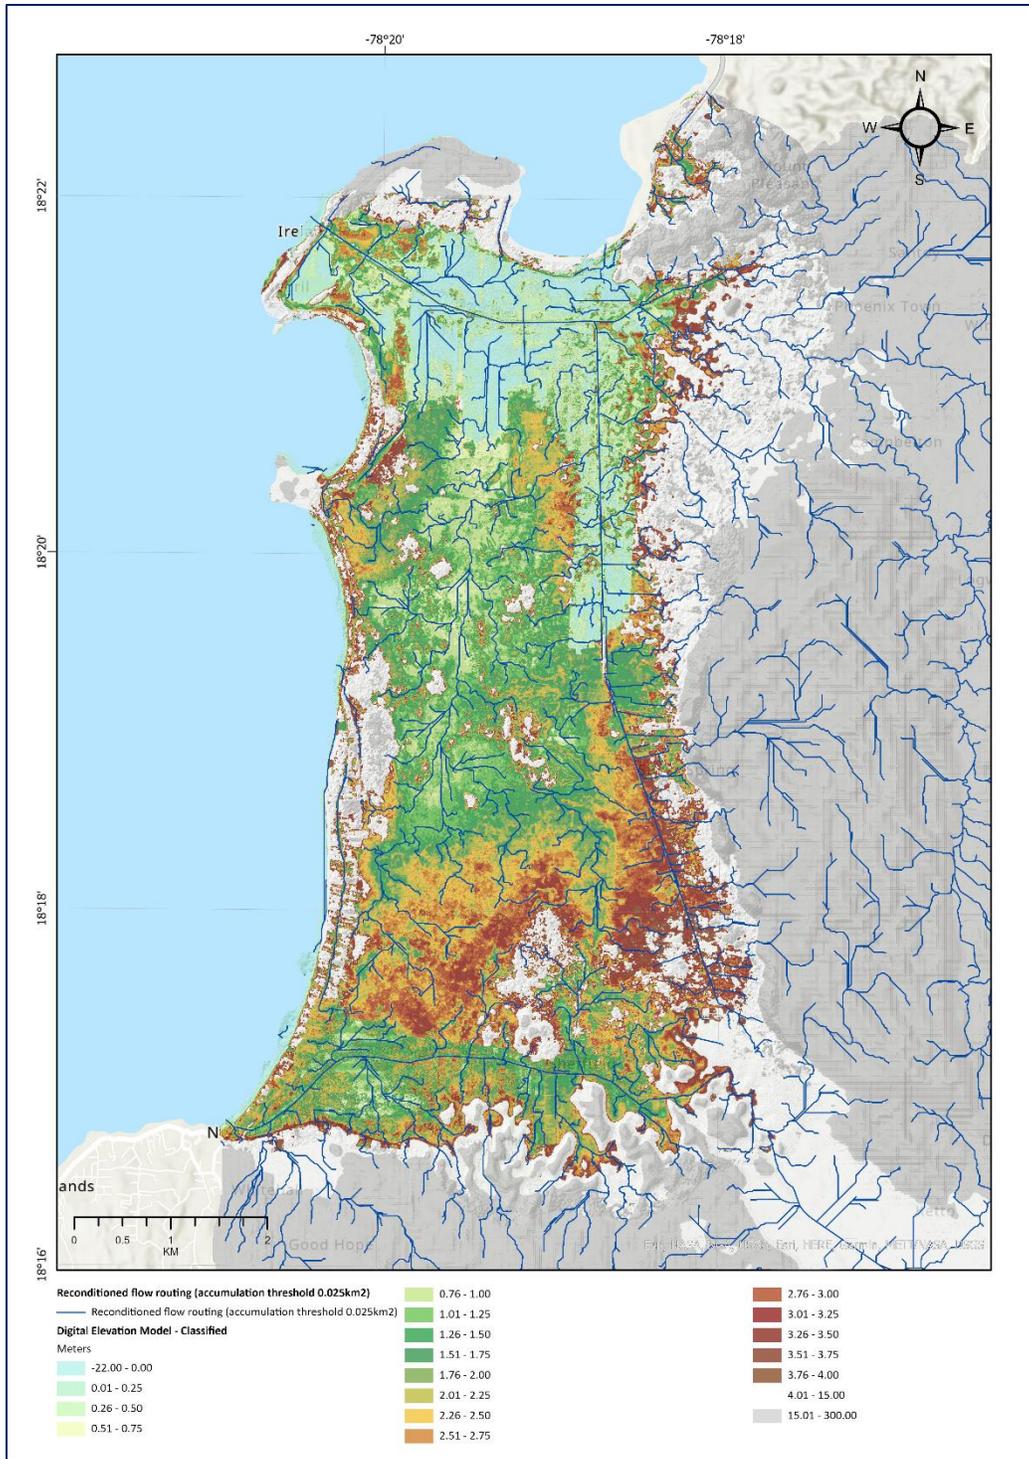
Drawing 9 Hydrological flow routes across the Negril Great Morass

Initial model runs did not result in flow routing consistent with the main rivers and canals, and some further editing of the DEM was undertaken to ensure the rivers and canals dominated the drainage patterns – the problem was primarily the inclusion of the coastal bridges across the rivers in the DEM, which acted as dams in the initial run-off modelling. Once these had been removed from the DEM, the runoff routing analysis reflected the main river and canal routes – this is shown below.
