Final Hydrological and Ecological Assessment Report

Identification of areas for baseline and continuous monitoring of water quantity in the Negril Environmental Protection Area, and Scenarios for reduced sedimentation and improved regularity of water flow based on degrees of land use change and restoration needs in the areas of intervention

Consultancy for the Hydrological Assessment of a Wetland Ecosystem

Prepared by Environmental Solutions Limited for the National Environment and Planning Agency (NEPA)

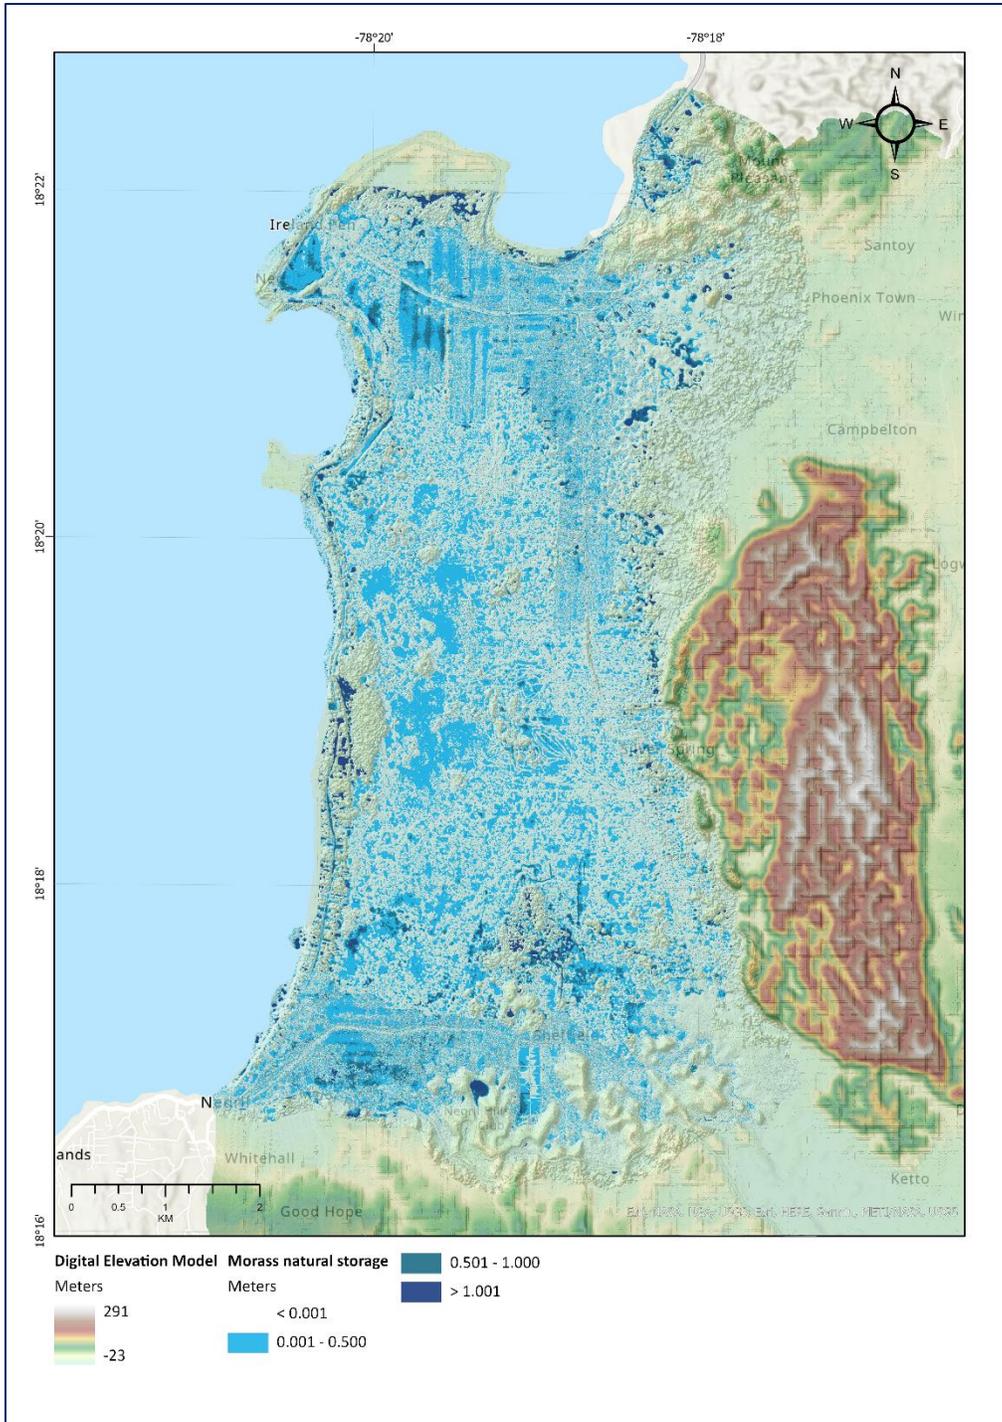
Drawing 10 Natural rainfall storage areas and depth within the Negril Morass

The existing natural storage within the Morass can therefore be calculated. Drawing No. 10 below shows the location and depth of water of each and every body of naturally ponding water in the Morass following heavy and/or prolonged rainfall.

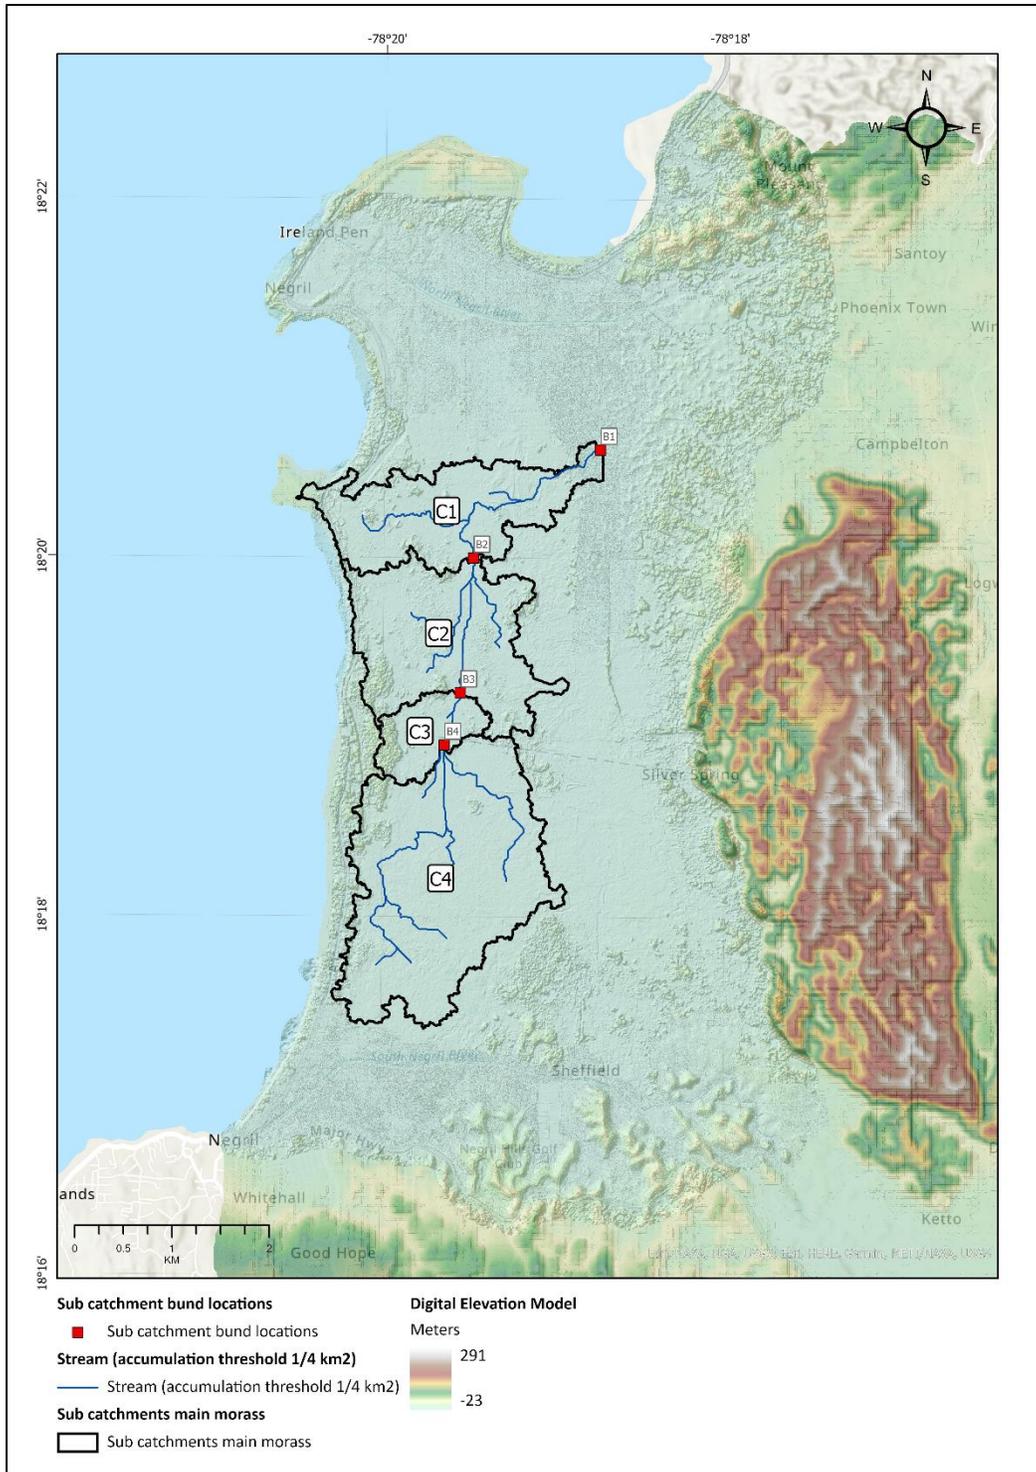
Drawing 11 Wild bush fire area assessed bund locations

Inundation modelling has been undertaken to assess what would happen if the area was bunded with low-lying earth embankments, which could retain a depth of 0.25m or 0.50m of water behind them. The results for 4 bund locations (mini-earth embankments) are shown below. The bund locations and the catchments which contribute rainfall to these bund locations are shown on Drawing No. 11.

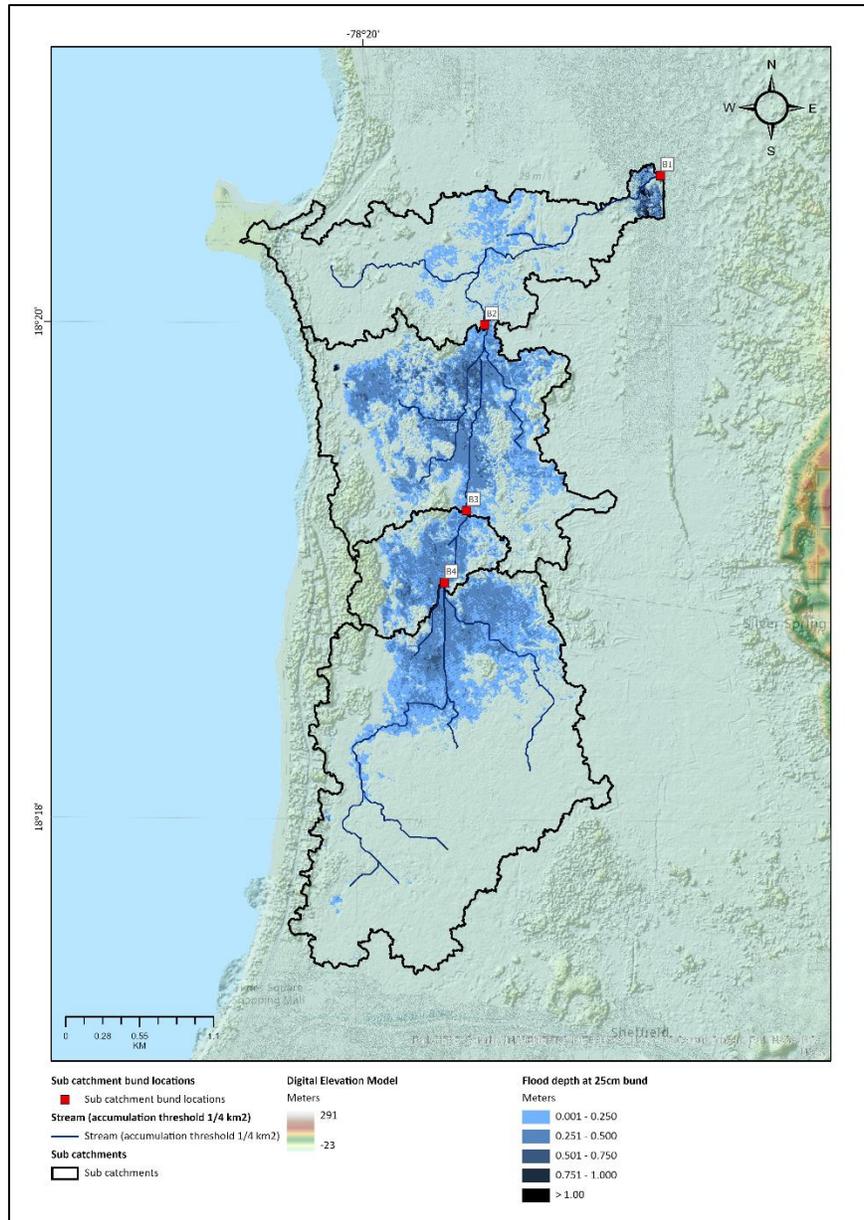
Drawing 12 Rainfall ponding at four 25cm high embankments

The areas and depths of rainfall ponding inundation are shown for all 4 bund locations for 0.25m high bunds, below.

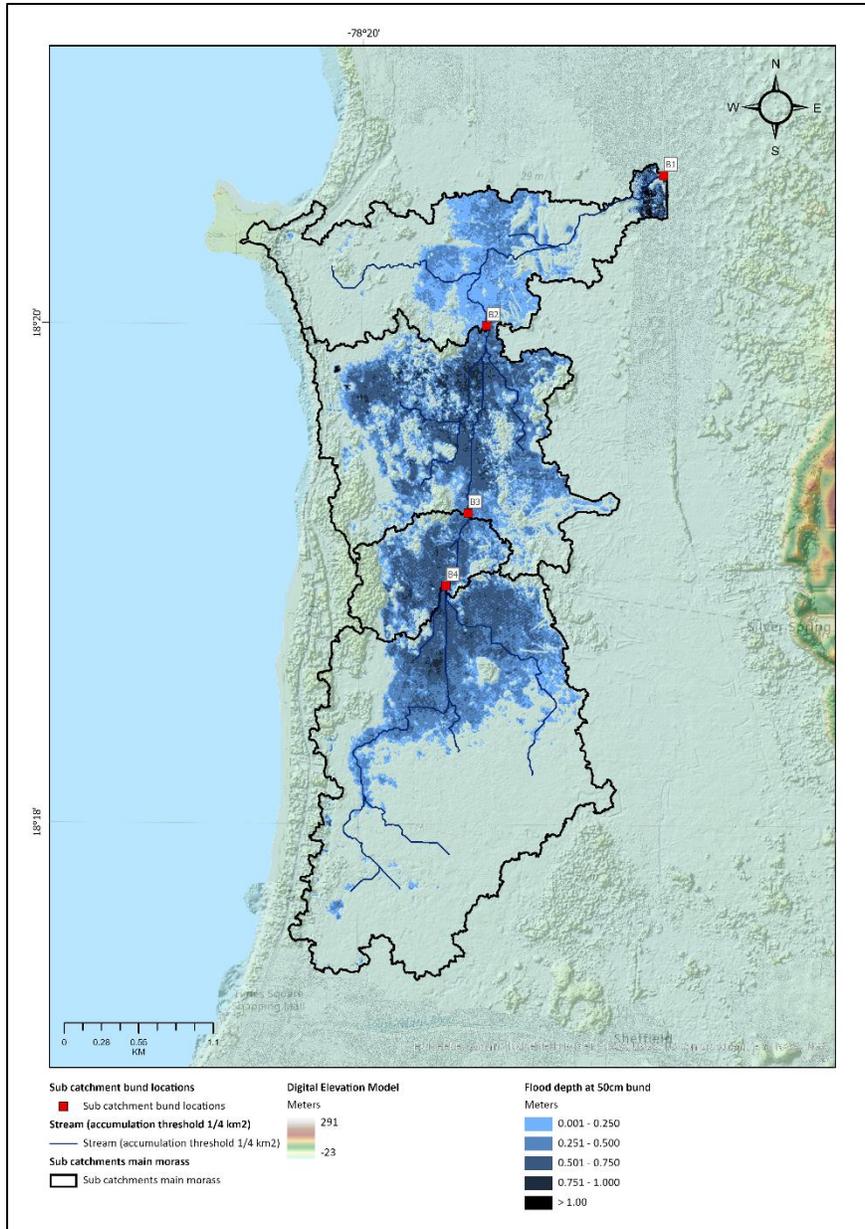
Drawing 13 Rainfall ponding at four 50cm high embankments

The areas and depths of rainfall ponding for the 4 bund locations for 0.50m bund heights are shown in the following drawing. The areas, depths and required bund lengths for each bund location individually are available in Appendix G.

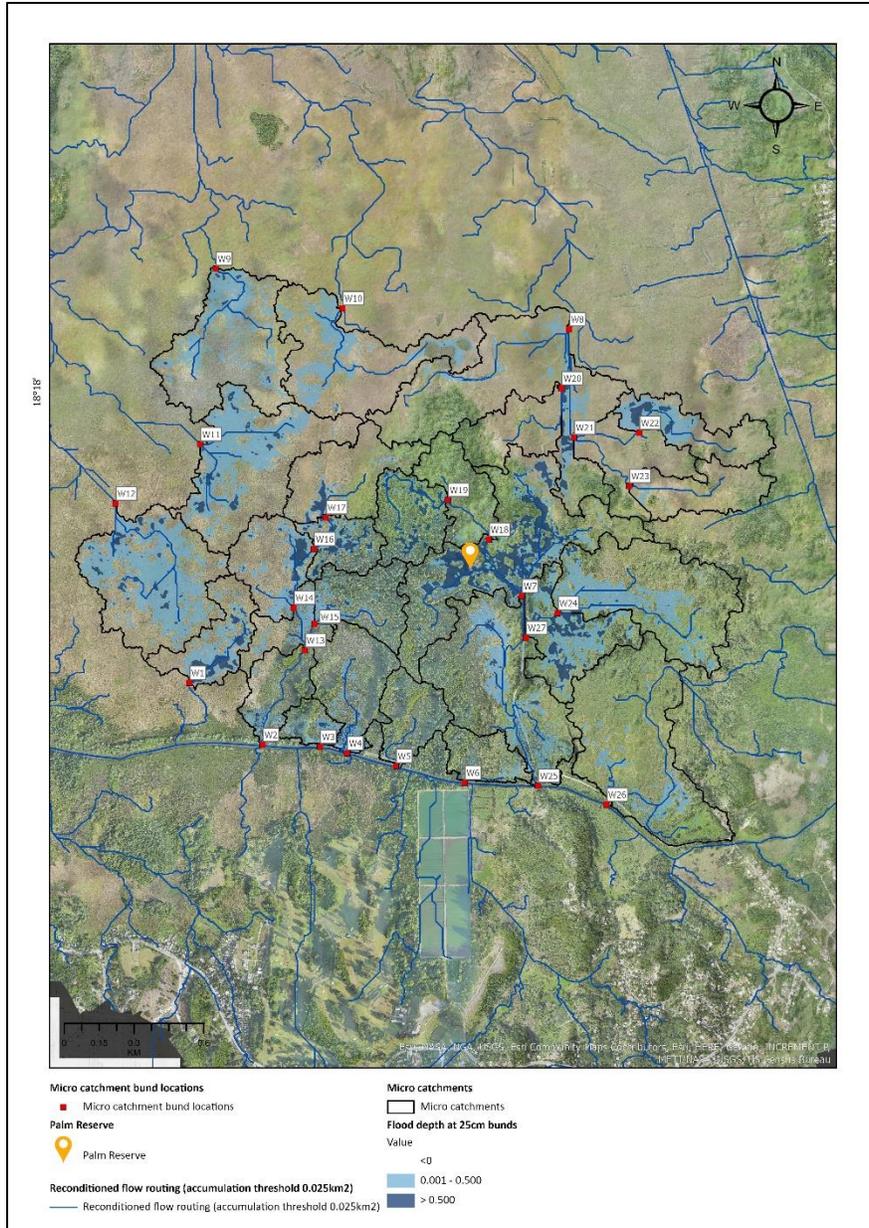
Drawing 14 Micro-catchment ponded areas for 25cm high embankments

The rainfall ponded areas and depths for the 25cm bunds/embankments are shown below for the 27 micro-catchments located radially around the Royal Palm Reserve.

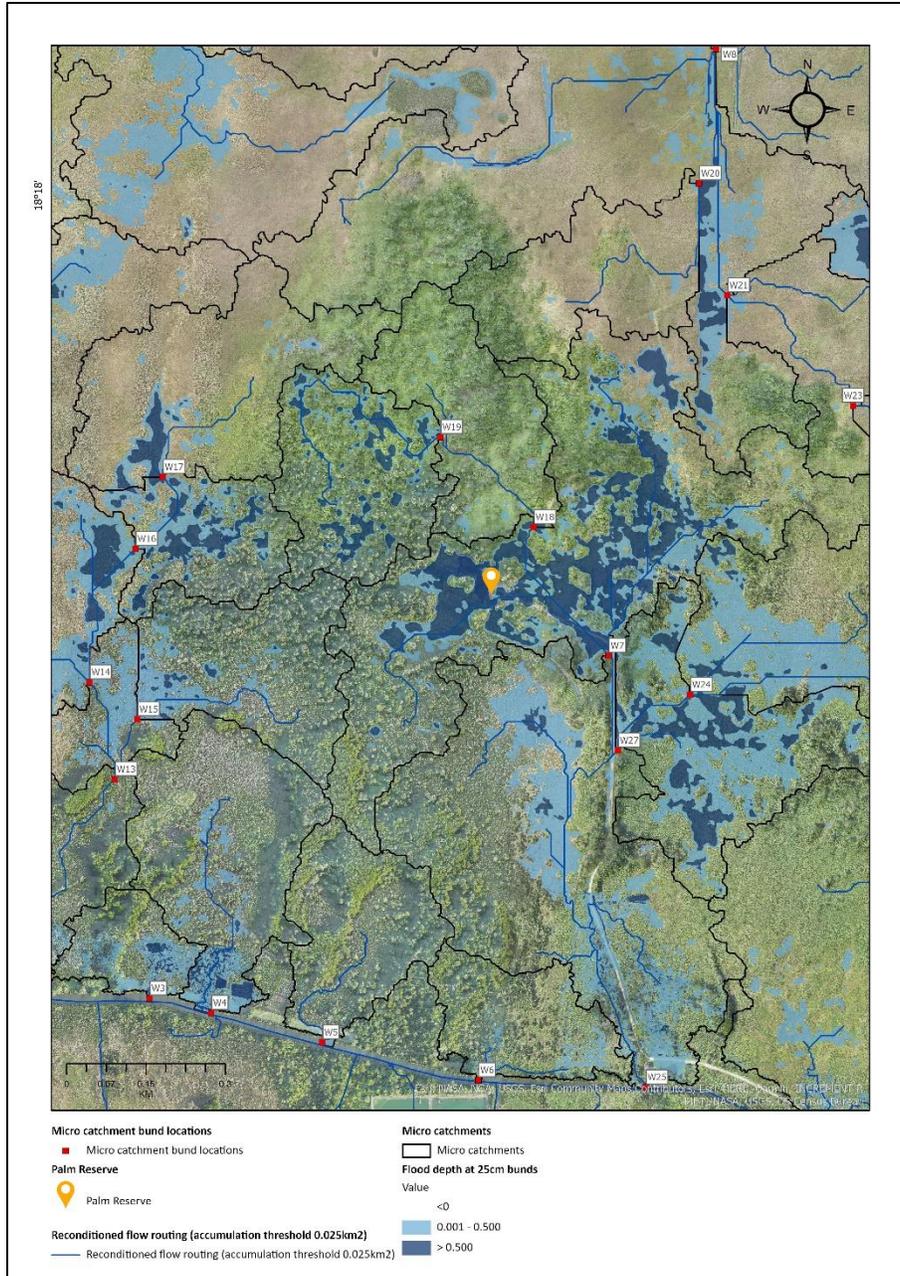
Drawing 15 Close-up of 25cm embankment rainfall pond extents around the Royal Palm Reserve

A close up of the area around the Royal Palm Reserve is shown below.

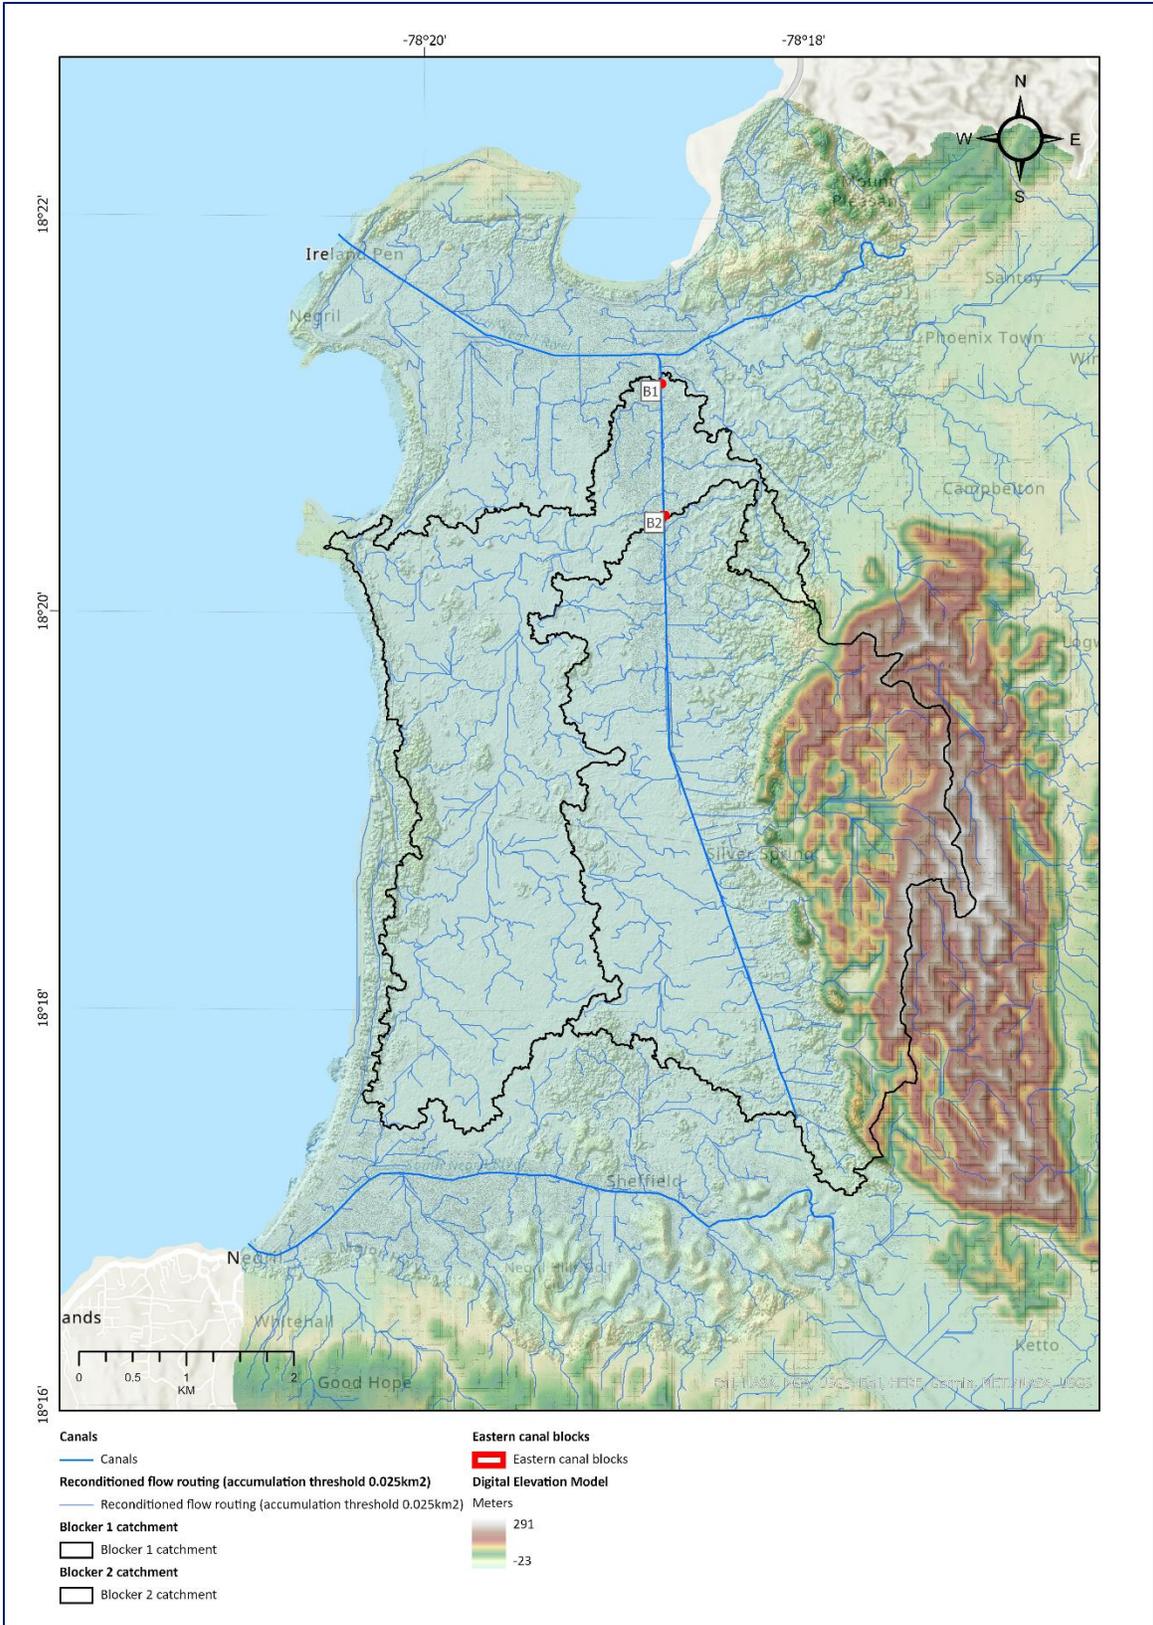
Drawing 16 Locations of assessed 'blockers' on the East Canal

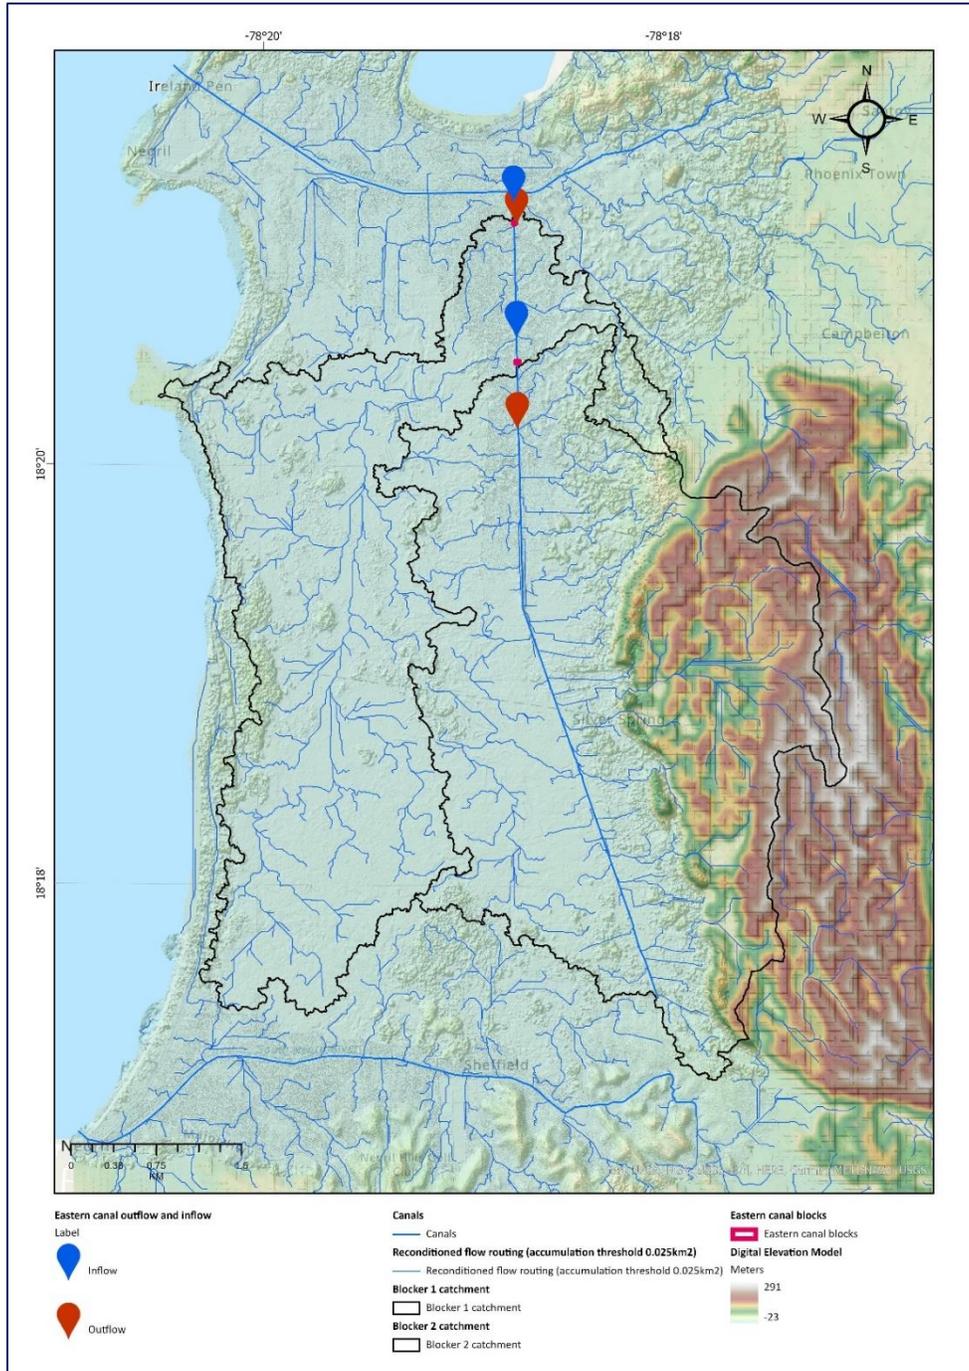
Drawing 17 Outflows and Inflows from the East Canal around the 'blockers'

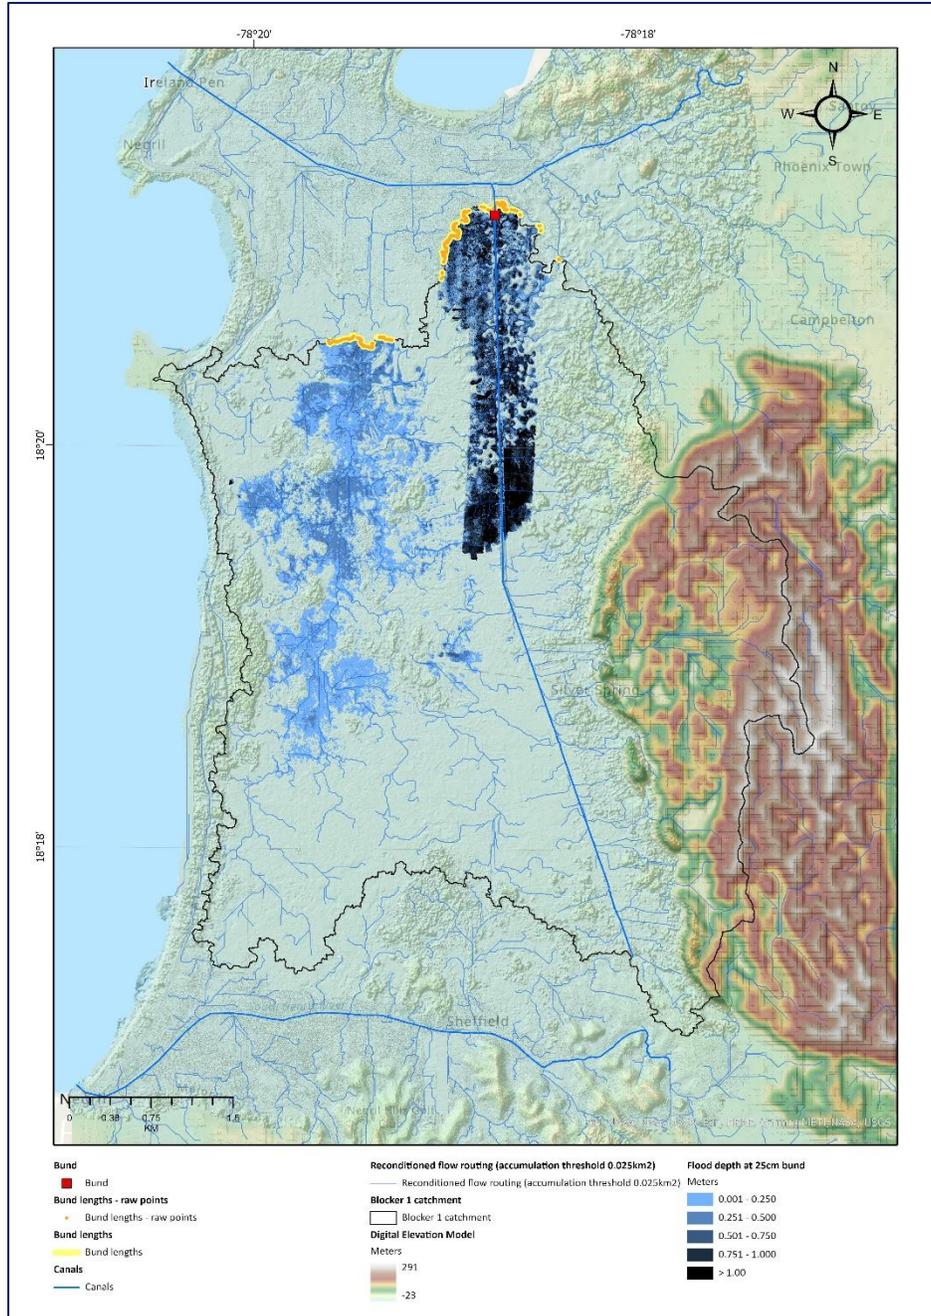
Drawing 18 Water retention areas and depths behind northern 25cm high weir on East Canal

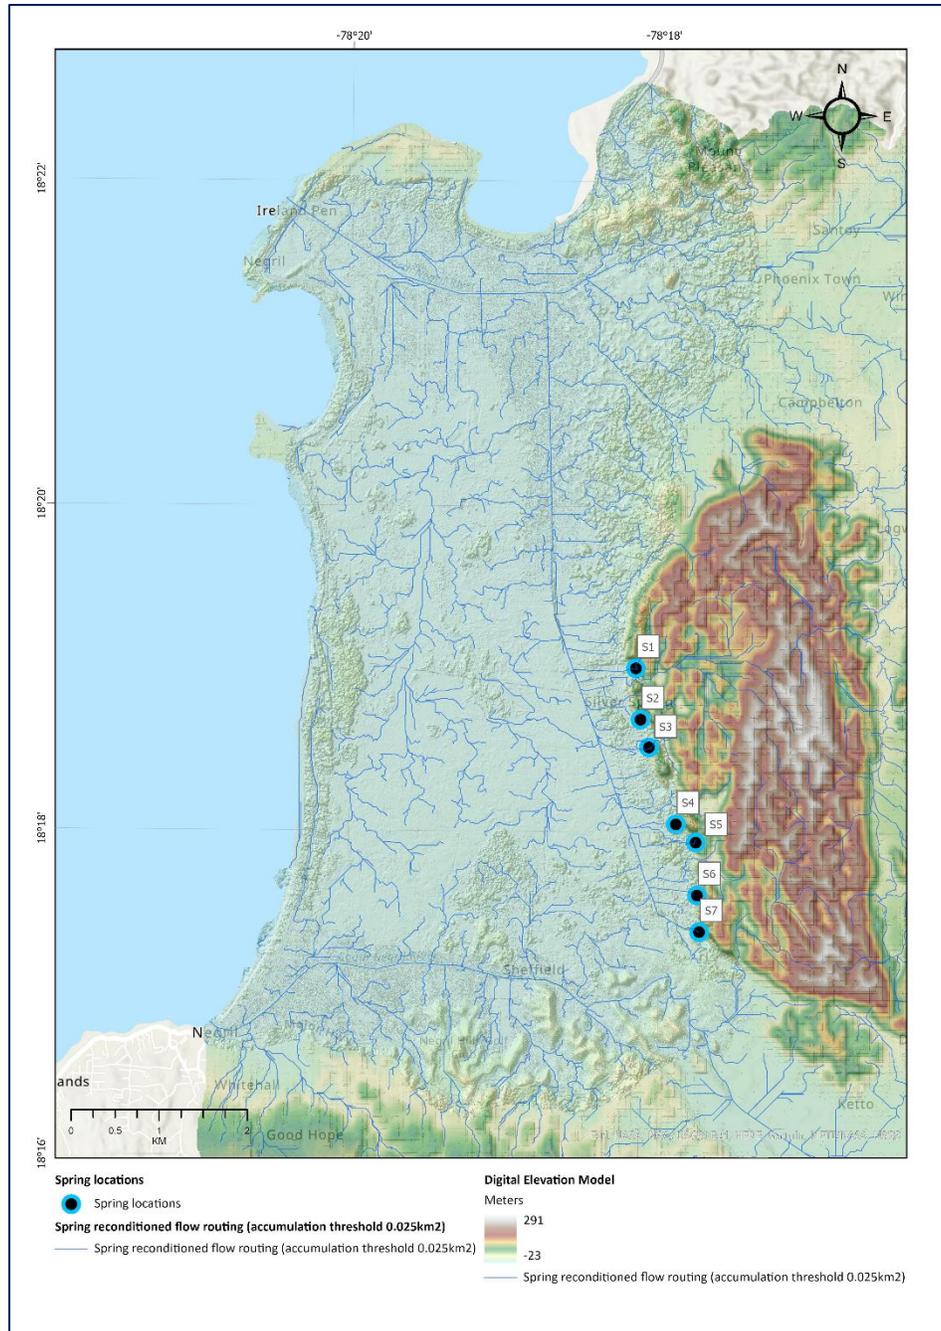
Drawing 19 Eastern spring locations with flow routes into Eastern Canal

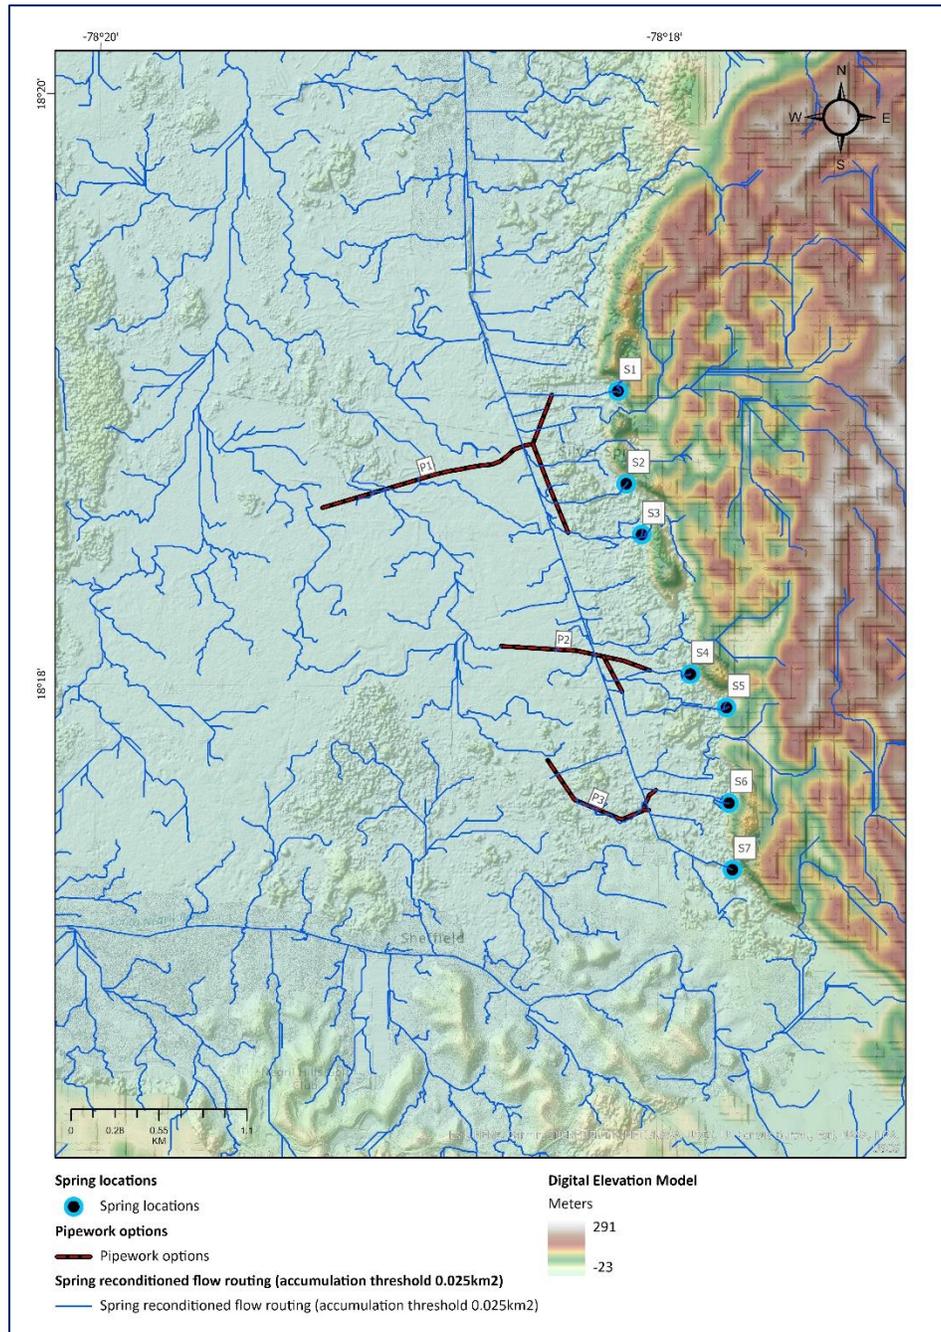
Drawing 20 Spring transfer routes – ditches and pipework

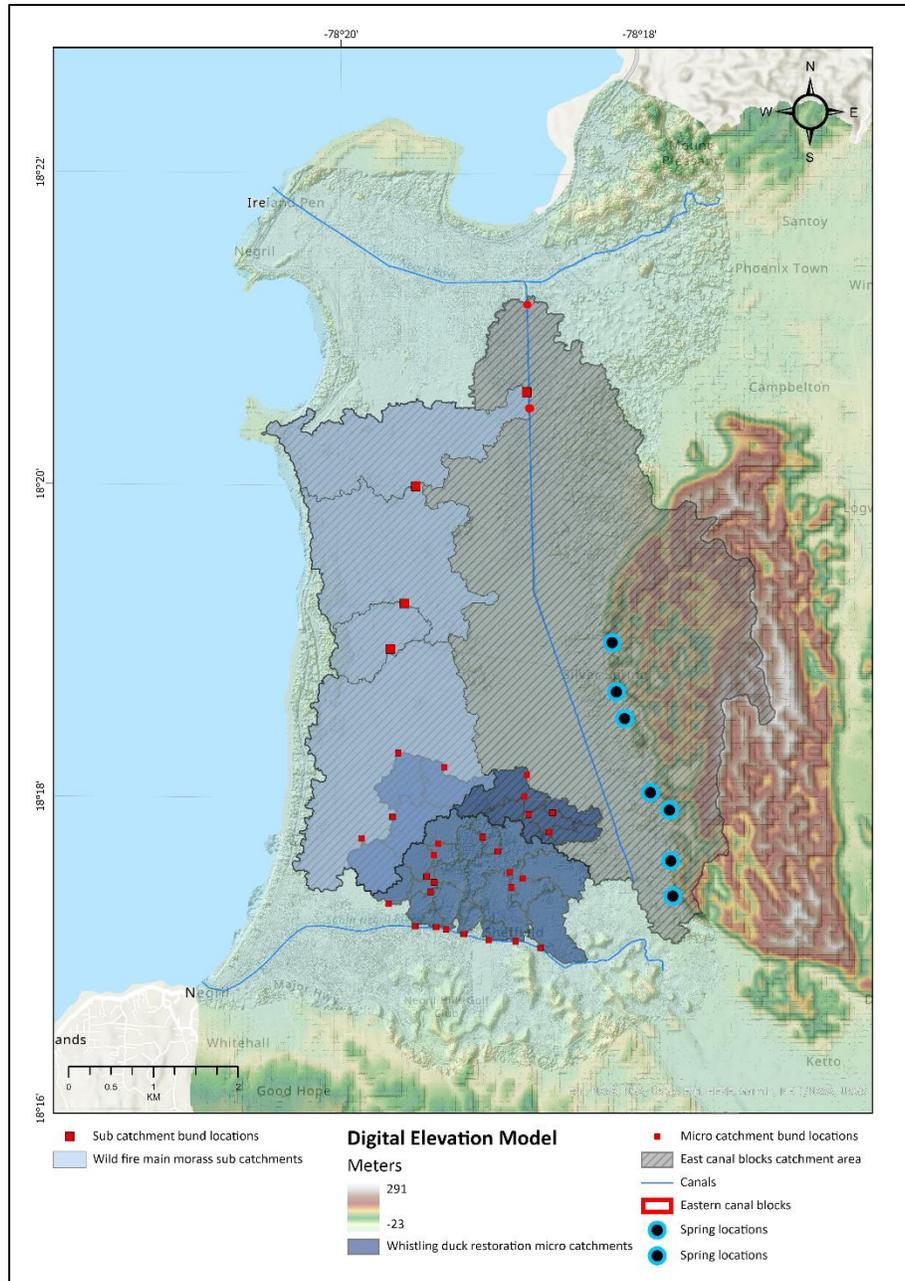
Drawing 22 Coverage of the hydrological restoration strategies

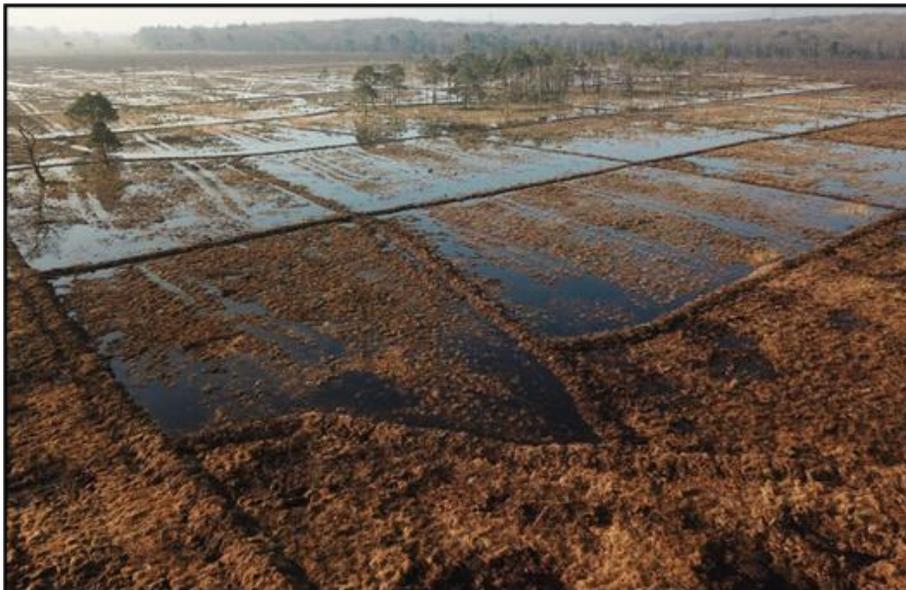
Figure 22 100mm high grid bunding constructed using an excavator in peatland

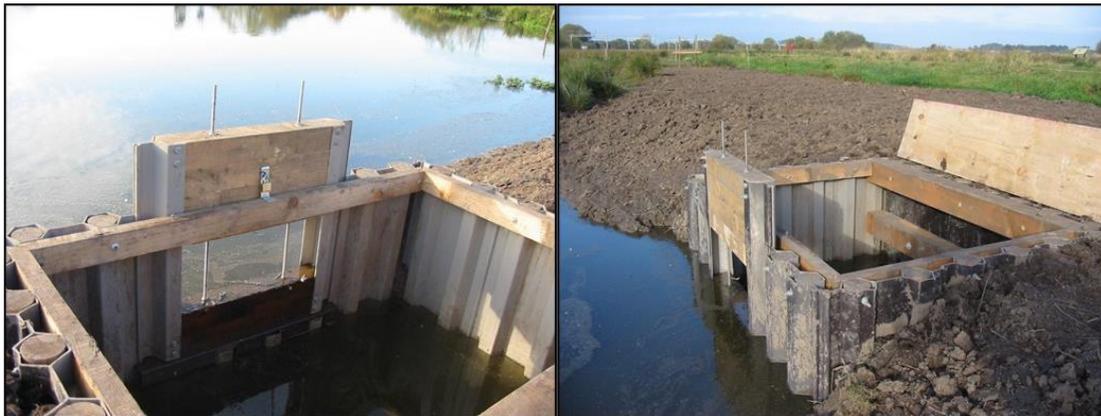
Figure 23 Weir using plastic piling sheets and lockable wooden planks to control water level

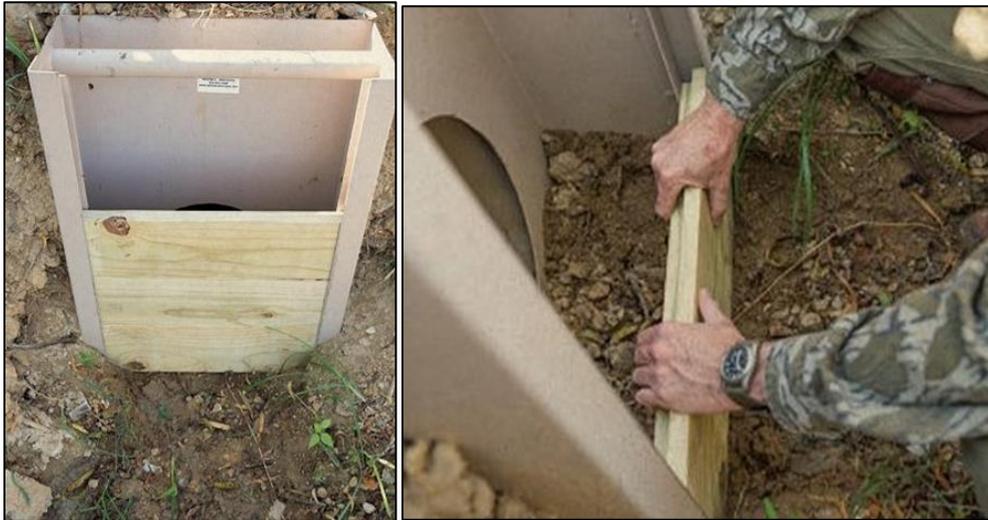
Figure 25 Prefabricated steel weir in earth embankment with changeable wooden weir boards

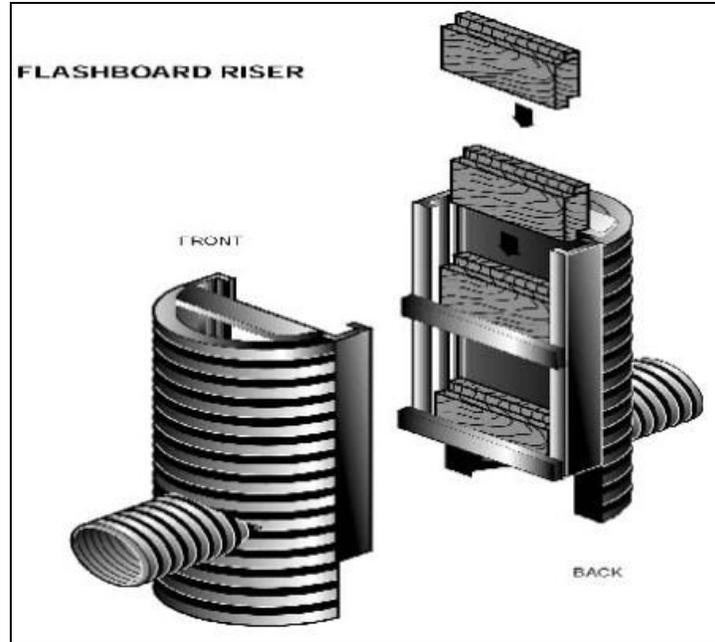
Figure 26 Prefabricated polypropylene twin wall pipe using wooden weir boards within a lockable chamber

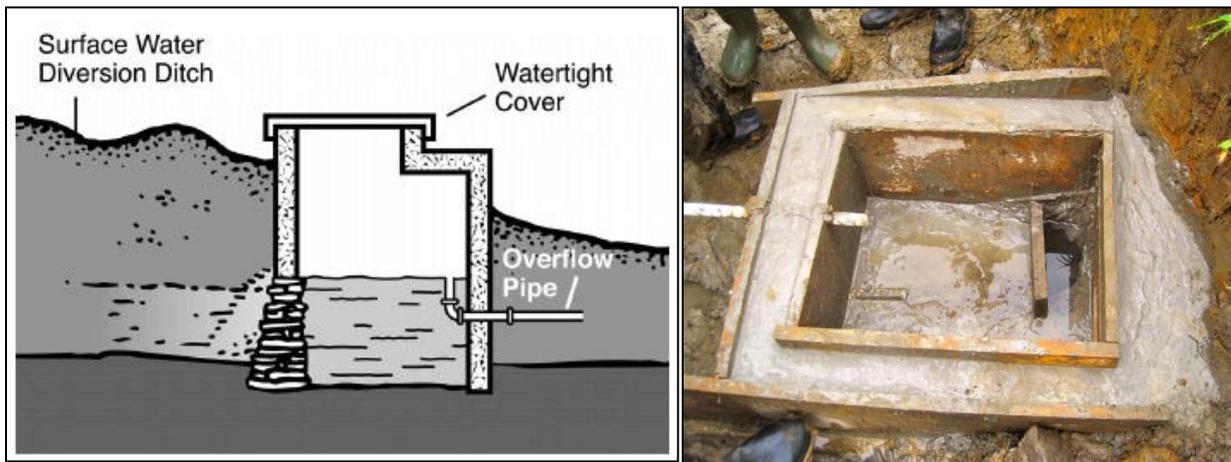
Figure 28 Simple spring box design and construction image

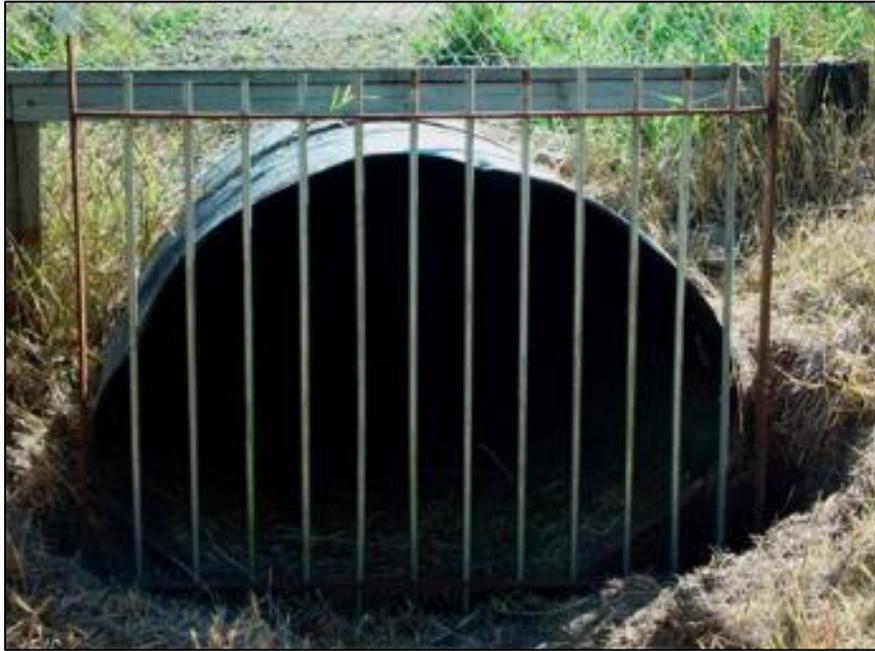
Figure 29 Culvert pipe to capture spring flow further downstream with protection screen

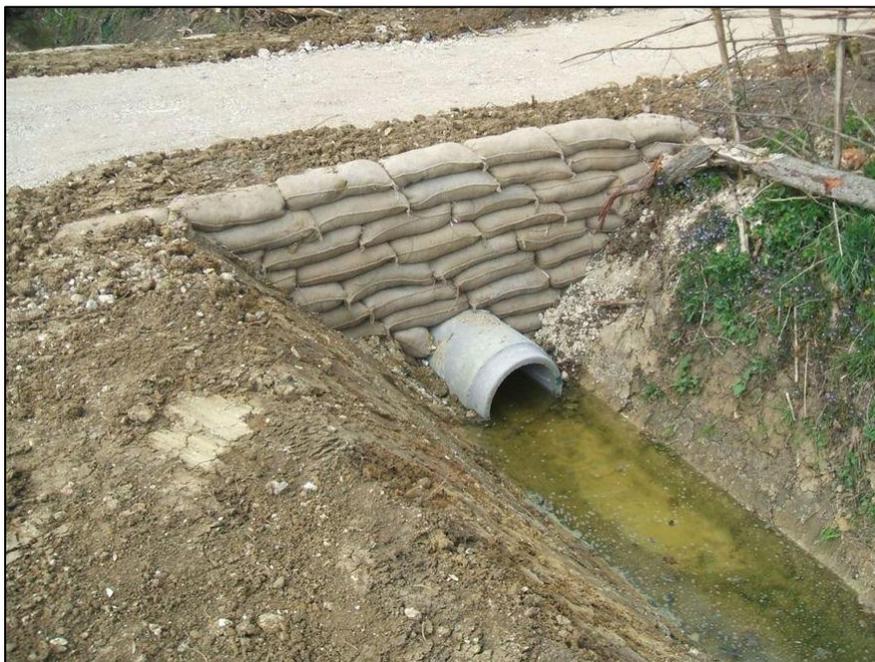
Figure 30 Low technology culvert headwall consisting of sandbags

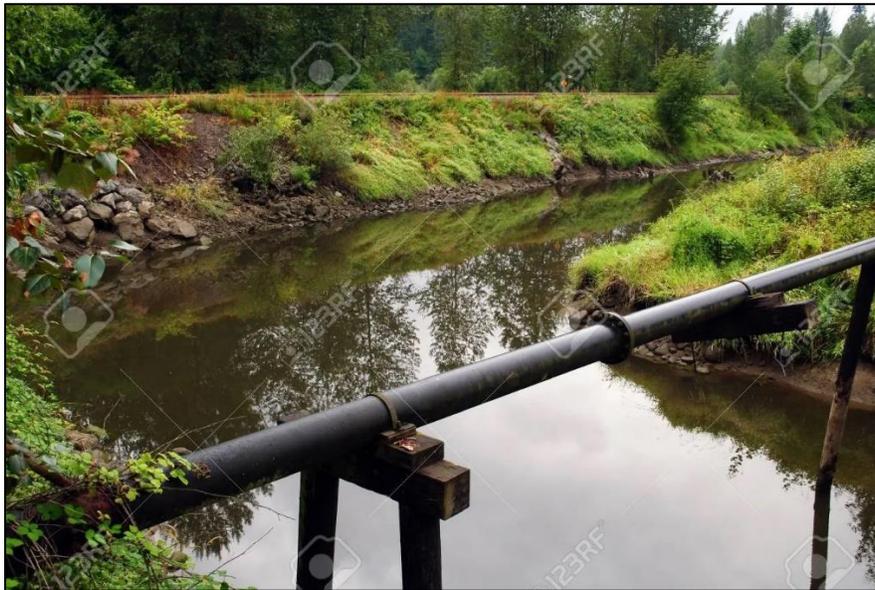
Figure 32 Low technology system to allow spring flow on slung pipe to cross over the canal
